Access Compliance Report

Public Rights-of-Way

(Curb Ramps)

Intersection ID: 19259	Main Street: VILLAGE_LAKE_DR	Cross Street: PEBBLESTONE_DR	Location: SE
ADA ID: 98930FA5E138	Ramp Type: PerpDiag	Initial Pass/Fail: Pass	Overall Compliance: No
		Severity Score: 15

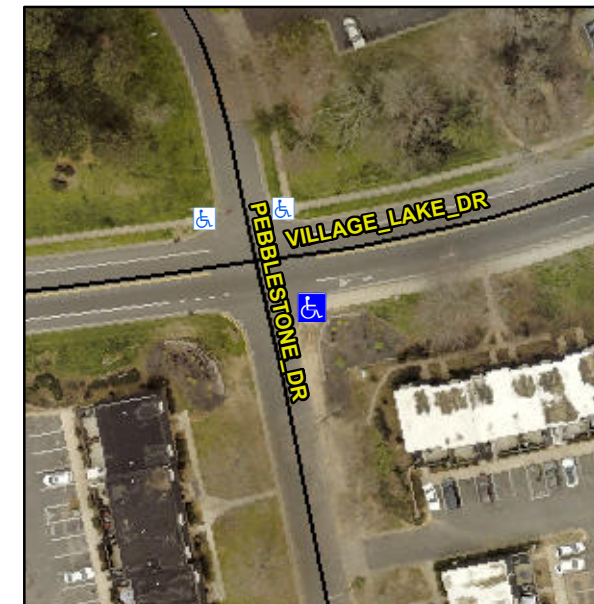
Not Found, R304.2.1, R304.2.2-Perp, R304.3.2-Para, R304.5.3, R304.5.4

Compliance	Description	Data	Compliance	Description	Data
N/A	Ramp Length (in)	85.0	Yes	Ramp Slope (%)	6.1
Yes	Ramp Width (in)	48.0	Yes	Ramp XSlope (%)	1.6
N/A	Flare Type LT	Sloped	N/A	Flare Type RT	N/A
N/A	Flare Slope LT (%)	1.3	Yes	Flare Slope RT (%)	3.5
N/A	Flare Traversable LT?	Yes	N/A	Flare Traversable RT?	Yes
No	Landing Length (in)	N/A	Yes	DWS Provided?	Yes
No	Landing Width (in)	N/A	Yes	DWS Contrast?	Yes
No	Landing Slope (%)	N/A	Yes	DWS Length (in)	24.5
No	Landing X Slope (%)	N/A	Yes	DWS Full Width?	Yes
N/A	Landing Curb? (Y/N)	No	Yes	DWS Offset (in)	0.0
N/A	Shared Landing?	N/A			
Yes	Gutter Ponding?	No	No	Gutter Slope (%)	8.6
Yes	Gutter Lip Ht (in)	0.0	Yes	Gutter X Slope (%)	0.1
N/A	Painted X Walk1?	No	N/A	Painted X Walk2?	No
	X Walk 1 Direction	To N		X Walk 2 Direction	To W
N/A	X Walk 1 Width (in)	N/A	N/A	X Walk 2 Width (in)	N/A
	X Walk 1 Slope (%)	4.5		X Walk 2 Slope (%)	4.0
	X Walk 1 X Slope (%)	5.5		X Walk 2 X Slope (%)	2.3

N/A	Ramp inside XWalk1?	N/A	N/A	Ramp inside XWalk2?	N/A
	Road Slope (%)	1.2	N/A	Clear Space?	Yes
	Road X Slope (%)	10.7	N/A	Clear Space to XWalk (in)	N/A
Yes	Any Obstructions?	No	Yes	Storm Grate/Utility Hazard?	No
	Obstruction Type			Storm Grate/Utility Type	
		N/A			N/A
			Yes	Surface Condition? (G/P)	Good

Remove & Replace Curb Ramp With Two New Directional Ramps or Equivalent. Remove & Replace Gutter.
