Access Compliance Report

Public Rights-of-Way

(Curb Ramps)

Intersection ID: 23916	Main Street: ARLANDES_DR	Cross Street: DEHAVILLAND_DR	Location:	W
ADA ID: 989BCE0C2778	Ramp Type: BlendTrans1	Initial Pass/Fail: Fail	Overall Compliance: No	Severity Score: 17.5

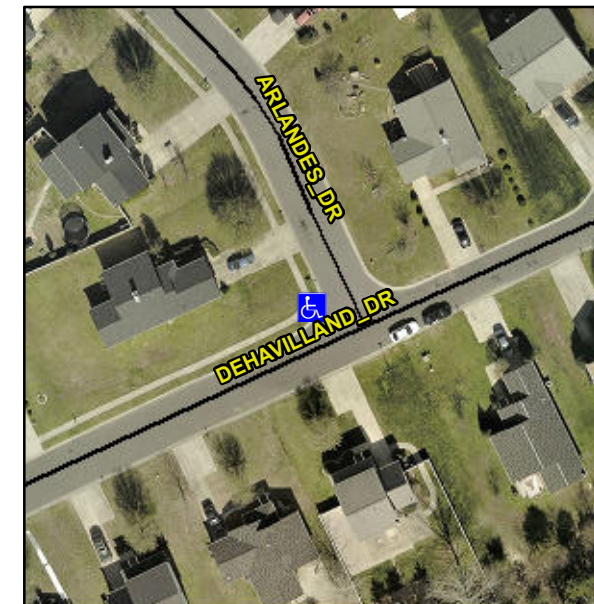
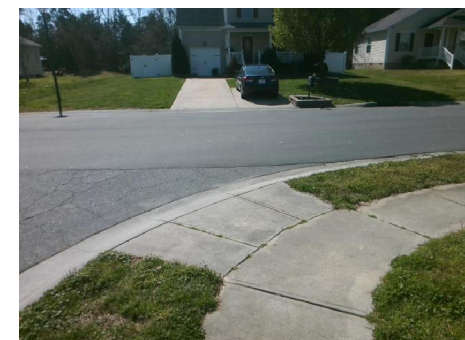
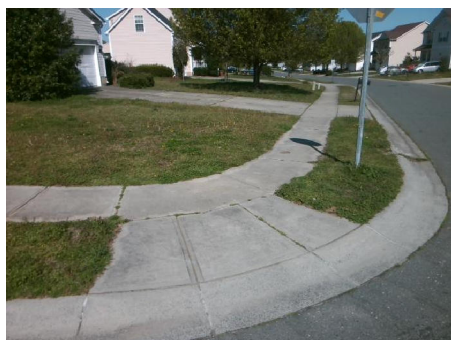
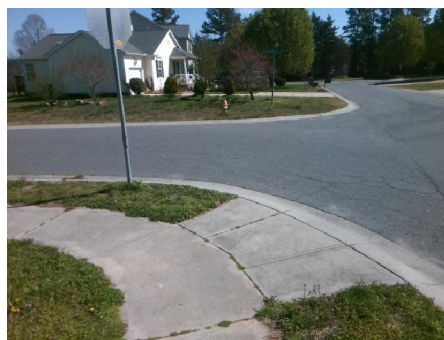
Not Found, R304.5.1

Compliance	Description	Data	Compliance	Description	Data
N/A	Ramp Length (in)	50.5	Yes	BlendTrans Slope (%)	3.8
No	Ramp Width (in)	32.5	Yes	BlendTrans XSlope (%)	0.8
N/A	Flare Type LT	N/A	N/A	Flare Type RT	N/A
N/A	Flare Slope LT (%)	N/A	N/A	Flare Slope RT (%)	N/A
N/A	Flare Traversable LT?	N/A	N/A	Flare Traversable RT?	N/A
N/A	Landing Length (in)	N/A	N/A	DWS Provided?	N/A
N/A	Landing Width (in)	N/A	N/A	DWS Contrast?	N/A
N/A	Landing Slope (%)	N/A	N/A	DWS Length (in)	N/A
N/A	Landing X Slope (%)	N/A	N/A	DWS Full Width?	N/A
N/A	Landing Curb? (Y/N)	N/A	N/A	DWS Offset (in)	N/A
N/A	Shared Landing?	N/A			
N/A	Gutter Ponding?	N/A	N/A	Gutter Slope (%)	N/A
N/A	Gutter Lip Ht (in)	N/A	N/A	Gutter X Slope (%)	N/A
N/A	Painted X Walk1?	No	N/A	Painted X Walk2?	No
	X Walk 1 Direction	To SE		X Walk 2 Direction	To NE
	X Walk 1 Width (in)	N/A		X Walk 2 Width (in)	N/A
	X Walk 1 Slope (%)	3.4		X Walk 2 Slope (%)	4.1
	X Walk 1 X Slope (%)	1.0		X Walk 2 X Slope (%)	0.4

N/A	Ramp inside XWalk1?	N/A	N/A	Ramp inside XWalk2?	N/A
	Road Slope (%)	2.3		Clear Space?	N/A
	Road X Slope (%)	3.0	N/A	Clear Space to XWalk (in)	N/A
N/A	Any Obstructions?	N/A	N/A	Storm Grate/Utility Hazard?	N/A
	Obstruction Type			Storm Grate/Utility Type	
		N/A			N/A
			Yes	Surface Condition? (G/P)	Good
			No	Curb Slope (%)	10.5

Remove & Replace Curb Ramp With Two New Directional Ramps or Equivalent.
