# Access Compliance Report

## Public Rights-of-Way

### (Curb Ramps)

Intersection ID: 46810	Main Street: ARBOR_VISTA_DR	Cross Street: CLAUDE_FREEMAN_DR	Location:	N
ADA ID: 98A3A0E861EB	Ramp Type: Combination1	Initial Pass/Fail: Fail	Overall Compliance: No	Severity Score: 26.25

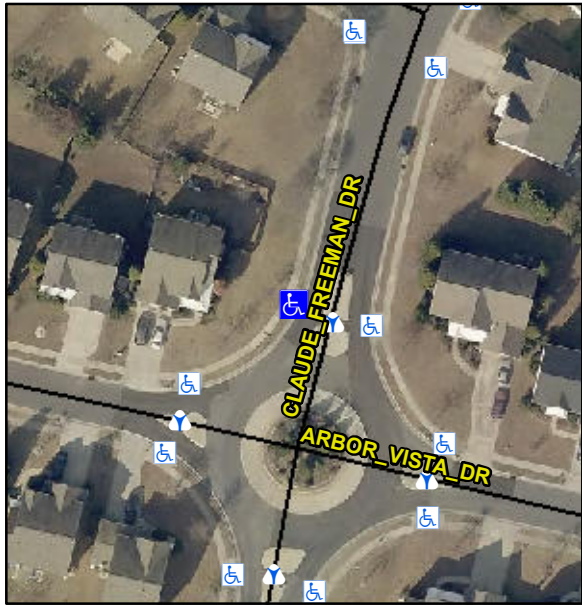
Possible Solutions:		<b>Compliance</b>	<b>Description</b>	<b>Data</b>	<b>Compliance</b>	<b>Description</b>	<b>Data</b>		
	<b>Remove &amp; Replace Entire Ramp.</b>		N/A	Ramp Length LT (in)	60.0	N/A	Ramp Length RT (in)	76.0		
			Yes	Ramp Width LT (in)	48.0	Yes	Ramp Width RT (in)	50.0		
			Yes	Ramp Slope LT (%)	4.3	No	Ramp Slope RT (%)	9.6		
			Yes	Ramp XSlope LT (%)	1.1	Yes	Ramp XSlope RT (%)	0.3		
			N/A	Ramp Length (in)	47.0	No	Ramp Slope (%)	17.8		
			Yes	Ramp Width (in)	57.0	No	Ramp XSlope (%)	3.5		
	Surveyor Notes:		N/A	Flare Type LT	N/A	N/A	Flare Type RT	N/A		
	<b>LT RP &lt; 5%</b>		N/A	Flare Slope LT (%)	N/A	N/A	Flare Slope RT (%)	N/A		
			N/A	Flare Traversable LT?	N/A	N/A	Flare Traversable RT?	N/A		
PROW/ADA:		N/A	Landing Length (in)	N/A	N/A	DWS Provided?	N/A			
<b>R304.2.2, R304.5.3, R304.3.2</b>		N/A	Landing Width (in)	N/A	N/A	DWS Contrast?	N/A

N/A	Landing Slope (%)	N/A	N/A	DWS Length (in)	N/A			
		N/A	Landing X Slope (%)	N/A	N/A	DWS Full Width?	N/A			
		N/A	Landing Curb? (Y/N)	N/A	N/A	DWS Offset (in)	N/A			
		N/A	Shared Landing?	N/A						
		N/A	Gutter Ponding?	N/A	N/A	Gutter Slope (%)	N/A			
		N/A	Gutter Lip Ht (in)	N/A	N/A	Gutter X Slope (%)	N/A			
		N/A	Painted X Walk1?	No	N/A	Painted X Walk2?	N/A			
			X Walk 1 Direction	To E		X Walk 2 Direction	N/A			
						X Walk 1 Width (in)	N/A		X Walk 2 Width (in)	N/A
						X Walk 1 Slope (%)	4.4		X Walk 2 Slope (%)	N/A
						X Walk 1 X Slope (%)	3.6		X Walk 2 X Slope (%)	N/A
		Total Cost:			N/A	Ramp inside XWalk1?	N/A	N/A	Ramp inside XWalk2?	N/A
						Road Slope (%)	N/A		Clear Space?	N/A
						Road X Slope (%)	N/A	N/A	Clear Space to XWalk (in)	N/A
								N/A	Any Obstruction?	N/A
									Obstruction Type	N/A
								N/A	Storm Grate/Utility Hazard?	N/A
									Storm Grate/Utility Type	N/A
					Yes	Surface Condition? (G/P)	Good
