# Access Compliance Report

## Public Rights-of-Way

### (Curb Ramps)

Intersection ID: 14556	Main Street: E_WORTHINGTON_AV	Cross Street: WINTHROP_AV	Location: W
ADA ID: 98A5A26D0488	Ramp Type: Perp	Initial Pass/Fail: Fail	Overall Compliance: No
Severity Score: 26.25			
Codes/Mitigation Info/Possible Solution		Field Measurements/Component Compliance

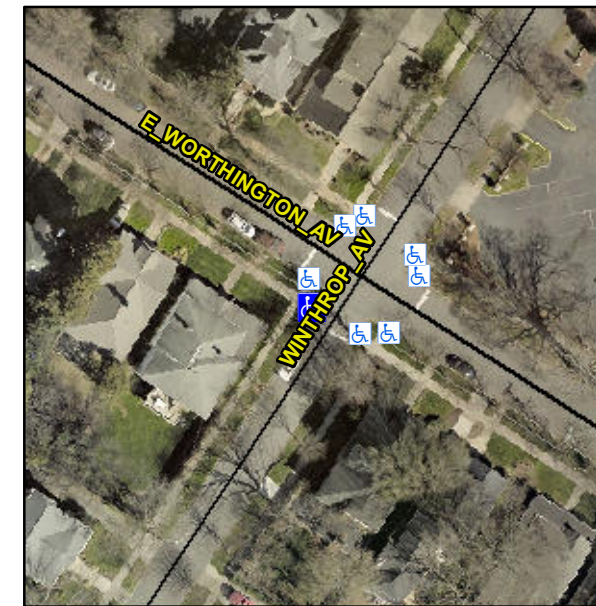
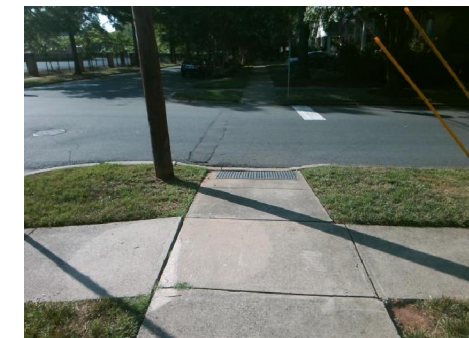
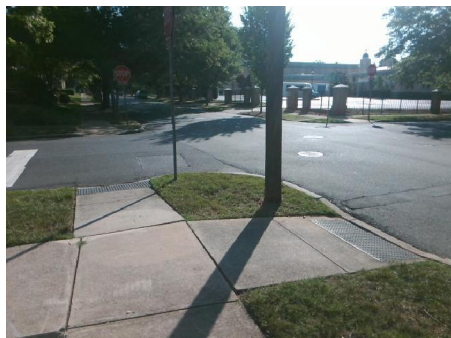
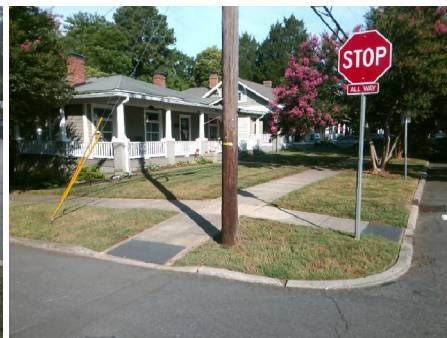
Compliance	Description	Data	Compliance	Description	Data
N/A	Ramp Length (in)	92.0	No	Ramp Slope (%)	17.7
Yes	Ramp Width (in)	60.0	No	Ramp XSlope (%)	3.3
N/A	Flare Type LT	N/A	N/A	Flare Type RT	N/A
N/A	Flare Slope LT (%)	N/A	N/A	Flare Slope RT (%)	N/A
N/A	Flare Traversable LT?	N/A	N/A	Flare Traversable RT?	N/A
N/A	Landing Length (in)	N/A	N/A	DWS Provided?	N/A
N/A	Landing Width (in)	N/A	N/A	DWS Contrast?	N/A
N/A	Landing Slope (%)	N/A	N/A	DWS Length (in)	N/A
N/A	Landing X Slope (%)	N/A	N/A	DWS Full Width?	N/A
N/A	Landing Curb? (Y/N)	N/A	N/A	DWS Offset (in)	N/A
N/A	Shared Landing?	N/A			
N/A	Gutter Ponding?	N/A	N/A	Gutter Slope (%)	N/A
N/A	Gutter Lip Ht (in)	N/A	N/A	Gutter X Slope (%)	N/A
N/A	Painted X Walk1?	No	N/A	Painted X Walk2?	N/A
	X Walk 1 Direction	To SE		X Walk 2 Direction	N/A
N/A	X Walk 1 Width (in)	N/A	N/A	X Walk 2 Width (in)	N/A
	X Walk 1 Slope (%)	2.8		X Walk 2 Slope (%)	N/A
	X Walk 1 X Slope (%)	5.3		X Walk 2 X Slope (%)	N/A

N/A	Ramp inside XWalk1?	N/A	N/A	Ramp inside XWalk2?	N/A
	Road Slope (%)	N/A	N/A	Clear Space?	N/A
	Road X Slope (%)	N/A	N/A	Clear Space to XWalk (in)	N/A
N/A	Any Obstructions?	N/A	N/A	Storm Grate/Utility Hazard?	N/A
	Obstruction Type			Storm Grate/Utility Type	
		N/A			N/A
		Yes		Surface Condition? (G/P)	Good

**Remove & Replace Entire Ramp.**

**R304.2.2, R304.5.3**

Total Cost: \$ 1850.00
