# Access Compliance Report

## Public Rights-of-Way

### (Curb Ramps)

Intersection ID: 31243	Main Street: NEWFANE_RD	Cross Street: DAVID_COX_RD	Location: SW
ADA ID: 98A7186EF92F	Ramp Type: Perp	Initial Pass/Fail: Fail	Overall Compliance: No
Severity Score: 10			
Codes/Mitigation Info/Possible Solution		Field Measurements/Component Compliance

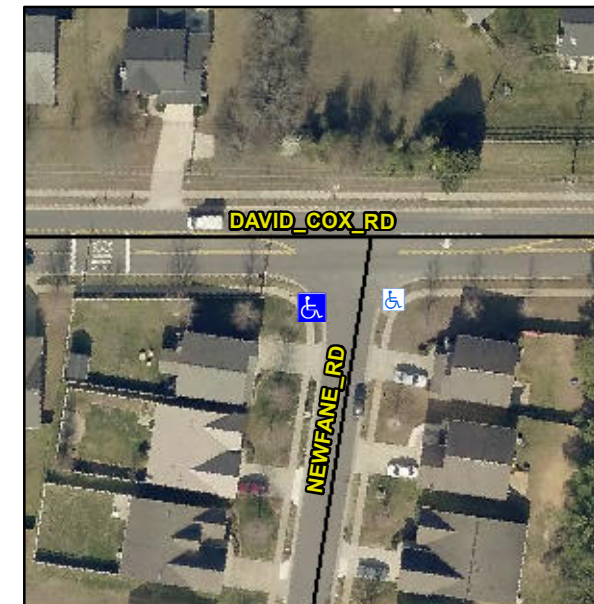
**Not Found, R304.5.1, R304.5.3**

Compliance	Description	Data	Compliance	Description	Data
N/A	Ramp Length (in)	48.0	Yes	Ramp Slope (%)	7.6
No	Ramp Width (in)	43.0	No	Ramp XSlope (%)	2.9
N/A	Flare Type LT	N/A	N/A	Flare Type RT	N/A
N/A	Flare Slope LT (%)	N/A	N/A	Flare Slope RT (%)	N/A
N/A	Flare Traversable LT?	N/A	N/A	Flare Traversable RT?	N/A
N/A	Landing Length (in)	N/A	N/A	DWS Provided?	N/A
N/A	Landing Width (in)	N/A	N/A	DWS Contrast?	N/A
N/A	Landing Slope (%)	N/A	N/A	DWS Length (in)	N/A
N/A	Landing X Slope (%)	N/A	N/A	DWS Full Width?	N/A
N/A	Landing Curb? (Y/N)	N/A	N/A	DWS Offset (in)	N/A
N/A	Shared Landing?	N/A			
N/A	Gutter Ponding?	N/A	N/A	Gutter Slope (%)	N/A
N/A	Gutter Lip Ht (in)	N/A	N/A	Gutter X Slope (%)	N/A
N/A	Painted X Walk1?	No	N/A	Painted X Walk2?	N/A
	X Walk 1 Direction	To E		X Walk 2 Direction	N/A
N/A	X Walk 1 Width (in)	N/A	N/A	X Walk 2 Width (in)	N/A
	X Walk 1 Slope (%)	4.9		X Walk 2 Slope (%)	N/A
	X Walk 1 X Slope (%)	2.3		X Walk 2 X Slope (%)	N/A

N/A	Ramp inside XWalk1?	N/A	N/A	Ramp inside XWalk2?	N/A
	Road Slope (%)	N/A	N/A	Clear Space?	N/A
	Road X Slope (%)	N/A	N/A	Clear Space to XWalk (in)	N/A
N/A	Any Obstructions?	N/A	N/A	Storm Grate/Utility Hazard?	N/A
	Obstruction Type			Storm Grate/Utility Type	
		N/A			N/A
		Yes		Surface Condition? (G/P)	Good

**Remove & Replace Entire Ramp.**

Total Cost: \$ 1850.00
