Access Compliance Report

Public Rights-of-Way

(Curb Ramps)

Intersection ID: 10025478	Main Street: E_JOHN_BELK_RA	Cross Street: E_STONEWALL_ST	Location: NE
ADA ID: 98BB7A441CE8	Ramp Type: PerpDiag	Initial Pass/Fail: Fail	Overall Compliance: No
		Severity Score: 8.75

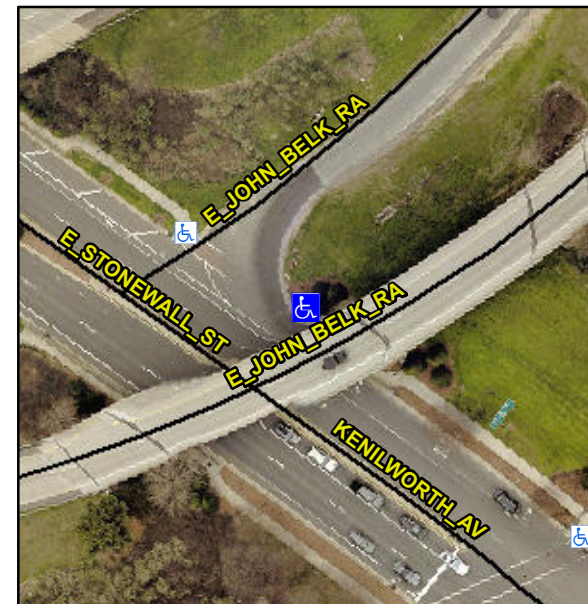
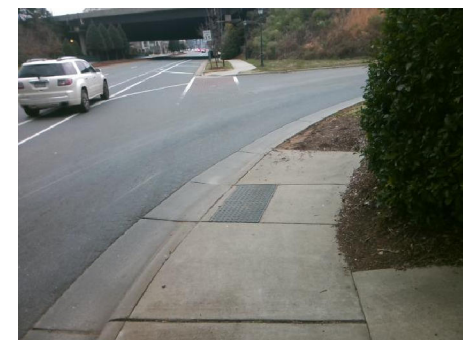
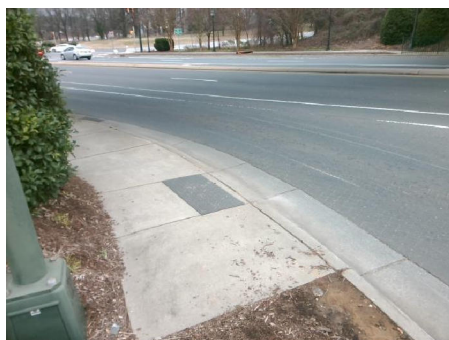
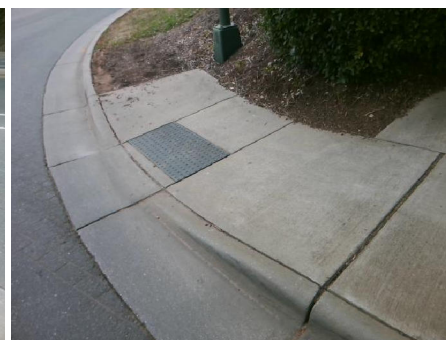
R304.5.1

Compliance	Description	Data	Compliance	Description	Data
N/A	Ramp Length (in)	67.0	Yes	Ramp Slope (%)	6.6
No	Ramp Width (in)	47.0	Yes	Ramp XSlope (%)	1.2
N/A	Flare Type LT	N/A	N/A	Flare Type RT	N/A
N/A	Flare Slope LT (%)	N/A	N/A	Flare Slope RT (%)	N/A
N/A	Flare Traversable LT?	N/A	N/A	Flare Traversable RT?	N/A
N/A	Landing Length (in)	N/A	N/A	DWS Provided?	N/A
N/A	Landing Width (in)	N/A	N/A	DWS Contrast?	N/A
N/A	Landing Slope (%)	N/A	N/A	DWS Length (in)	N/A
N/A	Landing X Slope (%)	N/A	N/A	DWS Full Width?	N/A
N/A	Landing Curb? (Y/N)	N/A	N/A	DWS Offset (in)	N/A
N/A	Shared Landing?	N/A			
N/A	Gutter Ponding?	N/A	N/A	Gutter Slope (%)	N/A
N/A	Gutter Lip Ht (in)	N/A	N/A	Gutter X Slope (%)	N/A
N/A	Painted X Walk1?	Yes	N/A	Painted X Walk2?	No
	X Walk 1 Direction	To NW		X Walk 2 Direction	To SW
N/A	X Walk 1 Width (in)	96.0	N/A	X Walk 2 Width (in)	N/A
	X Walk 1 Slope (%)	2.9		X Walk 2 Slope (%)	1.2
	X Walk 1 X Slope (%)	0.2		X Walk 2 X Slope (%)	1.7

N/A	Ramp inside XWalk1?	Yes	N/A	Ramp inside XWalk2?	N/A
	Road Slope (%)	0.6	N/A	Clear Space?	N/A
	Road X Slope (%)	3.6	N/A	Clear Space to XWalk (in)	N/A
N/A	Any Obstructions?	N/A	N/A	Storm Grate/Utility Hazard?	N/A
	Obstruction Type			Storm Grate/Utility Type	
		N/A			N/A
		Yes		Surface Condition? (G/P)	Good

Remove & Replace Curb Ramp With Two New Directional Ramps or Equivalent.
