Access Compliance Report

Public Rights-of-Way

(Curb Ramps)

Intersection ID: 47103	Main Street: POLK_AND_WHITE_RD	Cross Street: HATTIE_LITTLE_ST	Location: NW
ADA ID: 98BFF7EE28E4	Ramp Type: BlendTrans1	Initial Pass/Fail: Fail	Overall Compliance: No
		Severity Score: 10

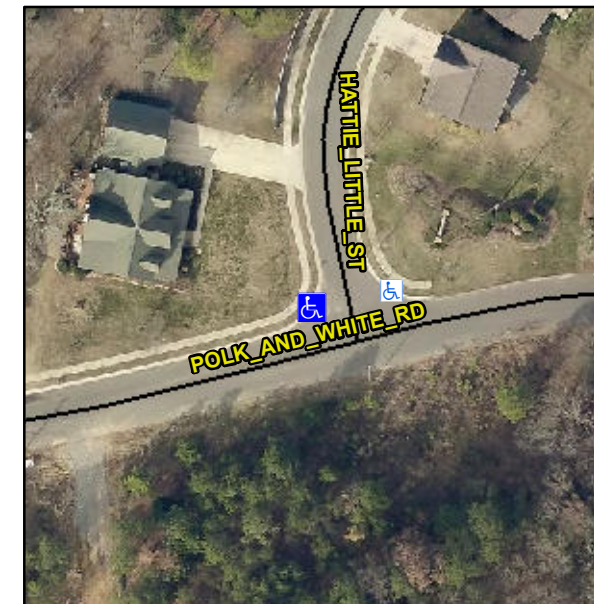
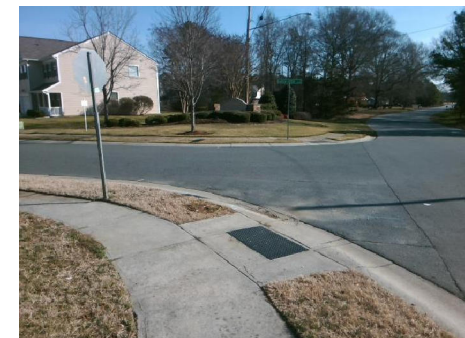
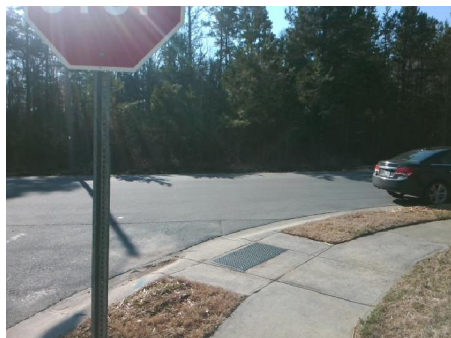
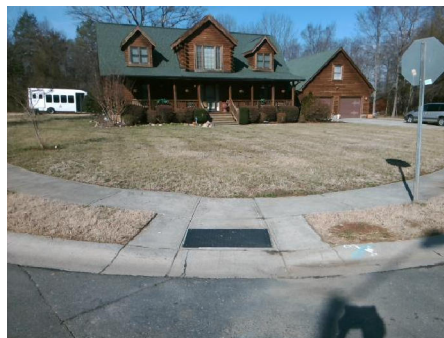
Not Found, R304.5.1, R304.5.3

Compliance	Description	Data	Compliance	Description	Data
N/A	Ramp Length (in)	46.0	Yes	BlendTrans Slope (%)	1.5
No	Ramp Width (in)	45.0	No	BlendTrans XSlope (%)	2.2
N/A	Flare Type LT	N/A	N/A	Flare Type RT	N/A
N/A	Flare Slope LT (%)	N/A	N/A	Flare Slope RT (%)	N/A
N/A	Flare Traversable LT?	N/A	N/A	Flare Traversable RT?	N/A
N/A	Landing Length (in)	N/A	N/A	DWS Provided?	N/A
N/A	Landing Width (in)	N/A	N/A	DWS Contrast?	N/A
N/A	Landing Slope (%)	N/A	N/A	DWS Length (in)	N/A
N/A	Landing X Slope (%)	N/A	N/A	DWS Full Width?	N/A
N/A	Landing Curb? (Y/N)	N/A	N/A	DWS Offset (in)	N/A
N/A	Shared Landing?	N/A			
N/A	Gutter Ponding?	N/A	N/A	Gutter Slope (%)	N/A
N/A	Gutter Lip Ht (in)	N/A	N/A	Gutter X Slope (%)	N/A
N/A	Painted X Walk1?	No	N/A	Painted X Walk2?	N/A
	X Walk 1 Direction	To E		X Walk 2 Direction	N/A
	X Walk 1 Width (in)	N/A		X Walk 2 Width (in)	N/A
	X Walk 1 Slope (%)	0.2		X Walk 2 Slope (%)	N/A
	X Walk 1 X Slope (%)	0.8		X Walk 2 X Slope (%)	N/A

N/A	Ramp inside XWalk1?	N/A	N/A	Ramp inside XWalk2?	N/A
	Road Slope (%)	0.8		Clear Space?	N/A
	Road X Slope (%)	0.2	N/A	Clear Space to XWalk (in)	N/A
N/A	Any Obstructions?	N/A	N/A	Storm Grate/Utility Hazard?	N/A
	Obstruction Type			Storm Grate/Utility Type	
		N/A			N/A
			Yes	Surface Condition? (G/P)	Good
			No	Curb Slope (%)	5.5

Remove & Replace Curb Ramp With Two New Directional Ramps or Equivalent.
