# Access Compliance Report

## Public Rights-of-Way

### (Curb Ramps)

Intersection ID: 11597	Main Street: E_20TH_ST	Cross Street: SEIGLE_AV	Location: W
ADA ID: 98CB09A199B0	Ramp Type: BlendTrans2	Initial Pass/Fail: Fail	Overall Compliance: No
		Severity Score: 8.75	
Codes/Mitigation Info/Possible Solution		Field Measurements/Component Compliance

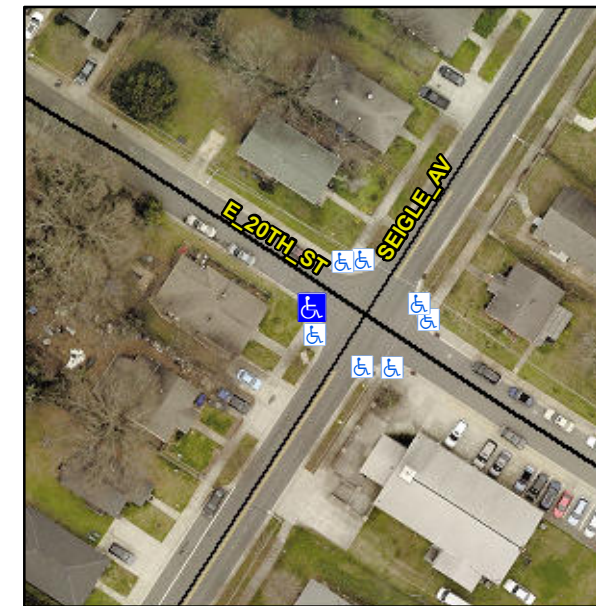
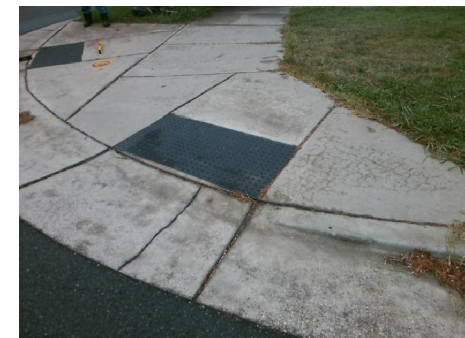
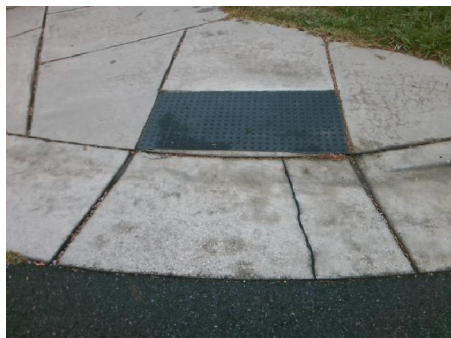
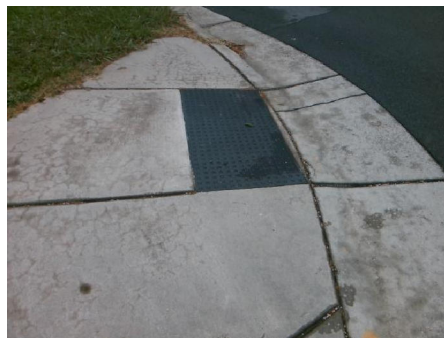
**CURB LIP 0.5**

**Not Found, R304.5.1**

Compliance	Description	Data	Compliance	Description	Data
N/A	Ramp Length (in)	60.5	Yes	BlendTrans Slope (%)	3.3
No	Ramp Width (in)	47.5	Yes	BlendTrans XSlope (%)	2.0
N/A	Flare Type LT	N/A	N/A	Flare Type RT	N/A
N/A	Flare Slope LT (%)	N/A	N/A	Flare Slope RT (%)	N/A
N/A	Flare Traversable LT?	N/A	N/A	Flare Traversable RT?	N/A
N/A	Landing Length (in)	N/A	N/A	DWS Provided?	N/A
N/A	Landing Width (in)	N/A	N/A	DWS Contrast?	N/A
N/A	Landing Slope (%)	N/A	N/A	DWS Length (in)	N/A
N/A	Landing X Slope (%)	N/A	N/A	DWS Full Width?	N/A
N/A	Landing Curb? (Y/N)	N/A	N/A	DWS Offset (in)	N/A
N/A	Shared Landing?	N/A			
N/A	Gutter Ponding?	N/A	N/A	Gutter Slope (%)	N/A
N/A	Gutter Lip Ht (in)	N/A	N/A	Gutter X Slope (%)	N/A
N/A	Painted X Walk1?	No	N/A	Painted X Walk2?	N/A
	X Walk 1 Direction	To E		X Walk 2 Direction	N/A
	X Walk 1 Width (in)	N/A		X Walk 2 Width (in)	N/A
	X Walk 1 Slope (%)	8.9		X Walk 2 Slope (%)	N/A
	X Walk 1 X Slope (%)	4.0		X Walk 2 X Slope (%)	N/A

N/A	Ramp inside XWalk1?	N/A	N/A	Ramp inside XWalk2?	N/A
	Road Slope (%)	4.0		Clear Space?	N/A
	Road X Slope (%)	8.9	N/A	Clear Space to XWalk (in)	N/A
N/A	Any Obstructions?	N/A	N/A	Storm Grate/Utility Hazard?	N/A
	Obstruction Type			Storm Grate/Utility Type	
		N/A			N/A
			Yes	Surface Condition? (G/P)	Good
			No	Curb Slope (%)	6.0

**Remove & Replace Curb Ramp With Two New Directional Ramps or Equivalent.**
