# Access Compliance Report

## Public Rights-of-Way

### (Curb Ramps)

Intersection ID: 10030235	Main Street: LAWTON_BLUFF_RD	Cross Street: N/A	Location: S
ADA ID: 98D93006CCD6	Ramp Type: PerpDiag	Initial Pass/Fail: Fail	Overall Compliance: No
Severity Score: 50			
Codes/Mitigation Info/Possible Solution		Field Measurements/Component Compliance

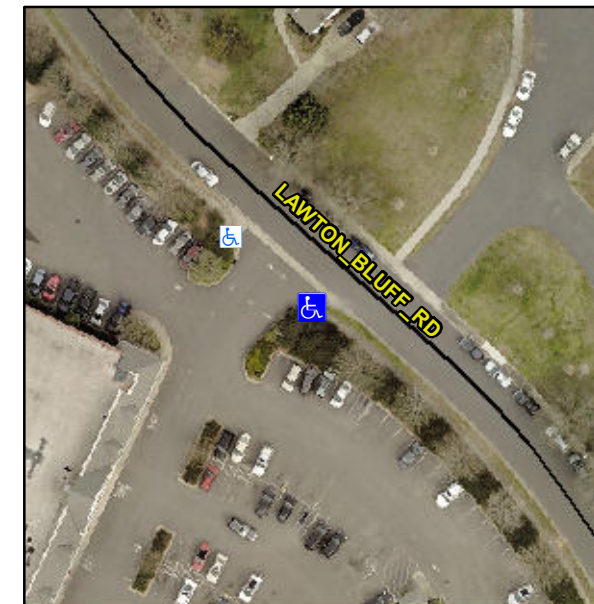
**Not Found, R304.2.2, R304.5.3**

Compliance	Description	Data	Compliance	Description	Data
N/A	Ramp Length (in)	48.0	No	Ramp Slope (%)	14.5
Yes	Ramp Width (in)	48.0	No	Ramp XSlope (%)	10.1
N/A	Flare Type LT	N/A	N/A	Flare Type RT	N/A
N/A	Flare Slope LT (%)	N/A	N/A	Flare Slope RT (%)	N/A
N/A	Flare Traversable LT?	N/A	N/A	Flare Traversable RT?	N/A
N/A	Landing Length (in)	N/A	N/A	DWS Provided?	N/A
N/A	Landing Width (in)	N/A	N/A	DWS Contrast?	N/A
N/A	Landing Slope (%)	N/A	N/A	DWS Length (in)	N/A
N/A	Landing X Slope (%)	N/A	N/A	DWS Full Width?	N/A
N/A	Landing Curb? (Y/N)	N/A	N/A	DWS Offset (in)	N/A
N/A	Shared Landing?	N/A			
N/A	Gutter Ponding?	N/A	N/A	Gutter Slope (%)	N/A
N/A	Gutter Lip Ht (in)	N/A	N/A	Gutter X Slope (%)	N/A
N/A	Painted X Walk1?	No	N/A	Painted X Walk2?	No
	X Walk 1 Direction	To NE		X Walk 2 Direction	To NW
N/A	X Walk 1 Width (in)	N/A	N/A	X Walk 2 Width (in)	N/A
	X Walk 1 Slope (%)	10.7		X Walk 2 Slope (%)	0.3
	X Walk 1 X Slope (%)	1.5		X Walk 2 X Slope (%)	7.6

N/A	Ramp inside XWalk1?	N/A	N/A	Ramp inside XWalk2?	N/A
	Road Slope (%)	5.3	N/A	Clear Space?	N/A
	Road X Slope (%)	5.2	N/A	Clear Space to XWalk (in)	N/A
N/A	Any Obstructions?	N/A	N/A	Storm Grate/Utility Hazard?	N/A
	Obstruction Type			Storm Grate/Utility Type	
		N/A			N/A
			Yes	Surface Condition? (G/P)	Good

**Remove & Replace Curb Ramp With Two New Directional Ramps or Equivalent.**

Total Cost: \$ 3200.00
