# Access Compliance Report

## Public Rights-of-Way

### (Curb Ramps)

Intersection ID: 12427	Main Street: W_STONEWALL_ST	Cross Street: S_MINT_ST	Location:	N
ADA ID: 98E3E18C7065	Ramp Type: Perp	Initial Pass/Fail: Fail	Overall Compliance: No	Severity Score: 12.5
Codes/Mitigation Info/Possible Solution		Field Measurements/Component Compliance

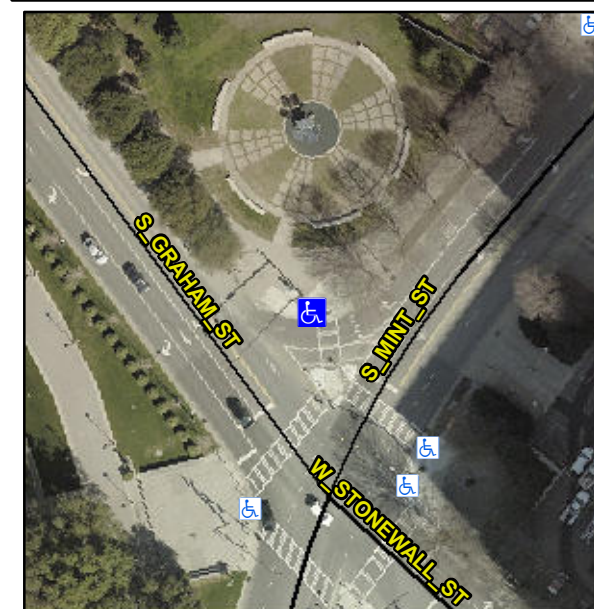
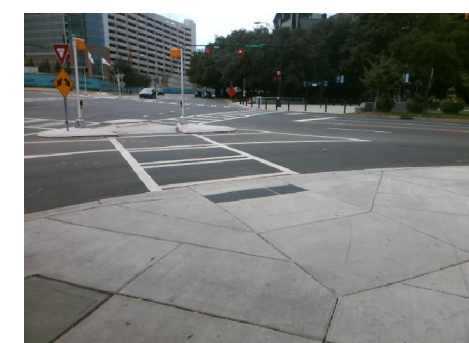
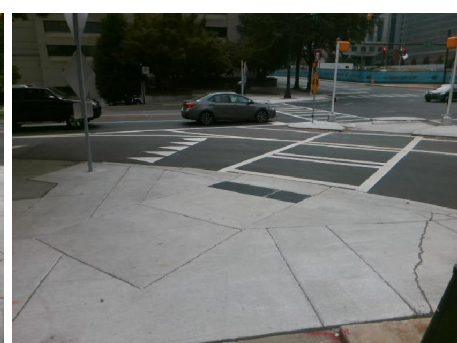
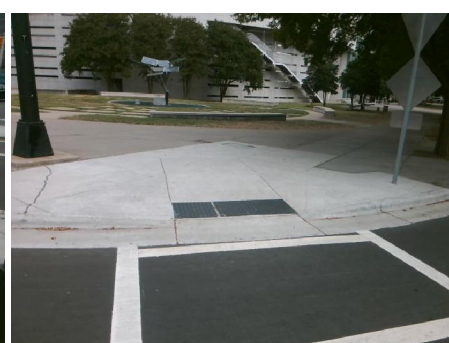
Compliance	Description	Data	Compliance	Description	Data
N/A	Ramp Length (in)	85.0	Yes	Ramp Slope (%)	8.2
Yes	Ramp Width (in)	72.0	No	Ramp XSlope (%)	6.4
N/A	Flare Type LT	N/A	N/A	Flare Type RT	N/A
N/A	Flare Slope LT (%)	N/A	N/A	Flare Slope RT (%)	N/A
N/A	Flare Traversable LT?	N/A	N/A	Flare Traversable RT?	N/A
N/A	Landing Length (in)	N/A	N/A	DWS Provided?	N/A
N/A	Landing Width (in)	N/A	N/A	DWS Contrast?	N/A
N/A	Landing Slope (%)	N/A	N/A	DWS Length (in)	N/A
N/A	Landing X Slope (%)	N/A	N/A	DWS Full Width?	N/A
N/A	Landing Curb? (Y/N)	N/A	N/A	DWS Offset (in)	N/A
N/A	Shared Landing?	N/A			
N/A	Gutter Ponding?	N/A	N/A	Gutter Slope (%)	N/A
N/A	Gutter Lip Ht (in)	N/A	N/A	Gutter X Slope (%)	N/A
N/A	Painted X Walk1?	Yes	N/A	Painted X Walk2?	N/A
	X Walk 1 Direction	To S		X Walk 2 Direction	N/A
N/A	X Walk 1 Width (in)	113.0	N/A	X Walk 2 Width (in)	N/A
	X Walk 1 Slope (%)	1.5		X Walk 2 Slope (%)	N/A
	X Walk 1 X Slope (%)	2.7		X Walk 2 X Slope (%)	N/A

N/A	Ramp inside XWalk1?	Yes	N/A	Ramp inside XWalk2?	N/A
	Road Slope (%)	N/A	N/A	Clear Space?	N/A
	Road X Slope (%)	N/A	N/A	Clear Space to XWalk (in)	N/A
N/A	Any Obstructions?	N/A	N/A	Storm Grate/Utility Hazard?	N/A
	Obstruction Type			Storm Grate/Utility Type	
			N/A		N/A
			Yes	Surface Condition? (G/P)	Good

**Remove & Replace Entire Ramp.**

**Not Found, R304.5.3**

\$ 1850.00
