Access Compliance Report

Public Rights-of-Way

| Intersection ID: 29713 | Main Street: COLE_MILL_RD | Cross Street: ROBESON_CREEK_DR | Location: | N |
| ADA ID: 98ECA71032C3 | Ramp Type: PerpDiag | Initial Pass/Fail: Fail | Overall Compliance: No | Severity Score: 25 |

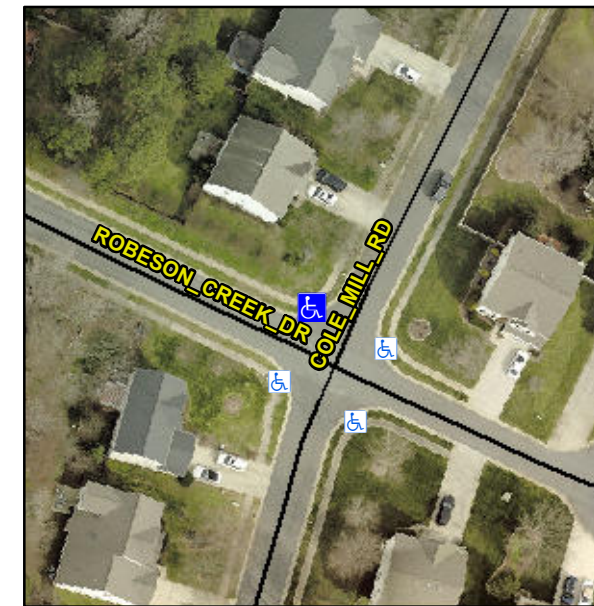
Not Found, R304.5.3

| Compliance | Description | Data | Compliance | Description | Data |
|---|---|---|---|---|---|
| N/A | Ramp Length (in) | 50.5 | Yes | Ramp Slope (%) | 6.1 |
| Yes | Ramp Width (in) | 53.0 | No | Ramp XSlope (%) | 8.8 |

Remove & Replace Curb Ramp With Two New Directional Ramps or Equivalent.
