# Access Compliance Report

## Public Rights-of-Way

### (Curb Ramps)

Intersection ID: 21893	Main Street: HIGHVIEW_RD	Cross Street: HINSDALE_ST	Location: SW
ADA ID: 98EFD2141187	Ramp Type: PerpDiag	Initial Pass/Fail: Fail	Overall Compliance: No
			Severity Score: 46.25

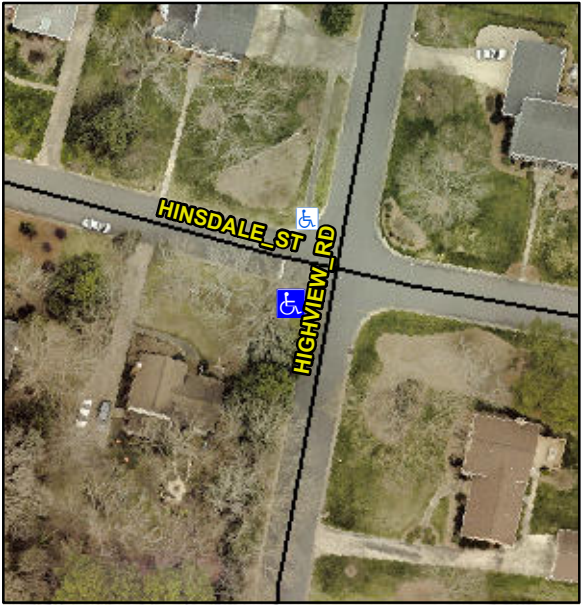
Possible Solutions:		<b>Compliance</b>	<b>Description</b>	<b>Data</b>	
	<b>Remove &amp; Replace Curb Ramp With Two New Directional Ramps or Equivalent.</b>		<b>N/A</b>	Ramp Length (in)	<b>214.0</b>	<b>Yes</b>
			<b>No</b>	Ramp Width (in)	<b>43.0</b>	<b>No</b>
			<b>N/A</b>	Flare Type LT	<b>N/A</b>	<b>N/A</b>
			<b>N/A</b>	Flare Slope LT (%)	<b>N/A</b>	<b>N/A</b>
			<b>N/A</b>	Flare Traversable LT?	<b>N/A</b>	<b>N/A</b>
			<b>N/A</b>	Landing Length (in)	<b>N/A</b>	<b>N/A</b>
			<b>N/A</b>	Landing Width (in)	<b>N/A</b>	<b>N/A</b>
			<b>N/A</b>	Landing Slope (%)	<b>N/A</b>	<b>N/A</b>
			<b>N/A</b>	Landing X Slope (%)	<b>N/A</b>	<b>N/A</b>
			<b>N/A</b>	Landing Curb? (Y/N)	<b>N/A</b>	<b>N/A</b>
			<b>N/A</b>	Shared Landing?	<b>N/A</b>	
			<b>N/A</b>	Gutter Ponding?	<b>N/A</b>	<b>N/A</b>
			<b>N/A</b>	Gutter Lip Ht (in)	<b>N/A</b>	<b>N/A</b>

<b>N/A</b>	Painted X Walk1?	<b>No</b>	<b>N/A</b>
				X Walk 1 Direction	<b>To E</b>	<b>To N</b>
			<b>N/A</b>	X Walk 1 Width (in)	<b>N/A</b>	<b>N/A</b>
				X Walk 1 Slope (%)	<b>7.6</b>	<b>4.7</b>
				X Walk 1 X Slope (%)	<b>6.7</b>	<b>9.4</b>
			<b>N/A</b>	Ramp inside XWalk1?	<b>N/A</b>	<b>N/A</b>
<p>Surveyor Notes:</p> <p><b>N/A</b></p> <p>PROW/ADA:</p> <p><b>Not Found, R304.5.1, R304.5.3</b></p>			<b>N/A</b>	Road Slope (%)	<b>10.5</b>	<b>N/A</b>
				Road X Slope (%)	<b>1.3</b>	<b>N/A</b>
			<b>N/A</b>	Any Obstructions?	<b>N/A</b>	<b>N/A</b>
				Obstruction Type		
					<b>N/A</b>	<b>N/A</b>
			<b>Yes</b>	Surface Condition? (G/P)		<b>Good</b>
Total Cost:		\$ 3200.00
