Access Compliance Report

Public Rights-of-Way

(Curb Ramps)

Intersection ID: 47754	Main Street: REBECCA_RUN_DR	Cross Street: BROCK_RN	Location:	E
ADA ID: 98F116DACAE0	Ramp Type: PerpDiag	Initial Pass/Fail: Fail	Overall Compliance: No	Severity Score: 22.5
Codes/Mitigation Info/Possible Solution		Field Measurements/Component Compliance

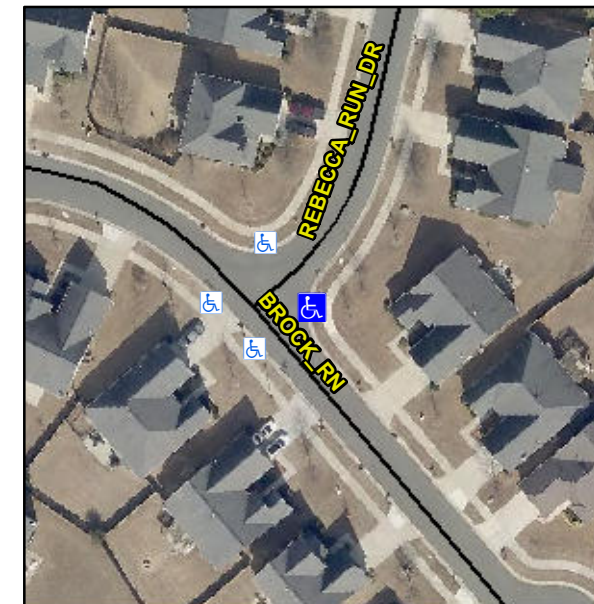
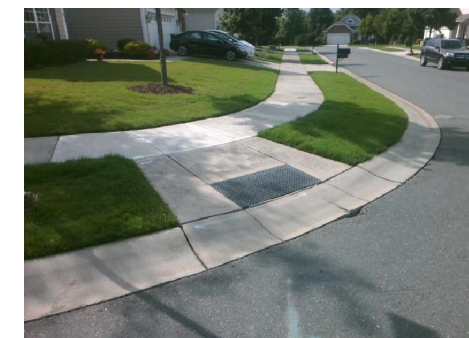
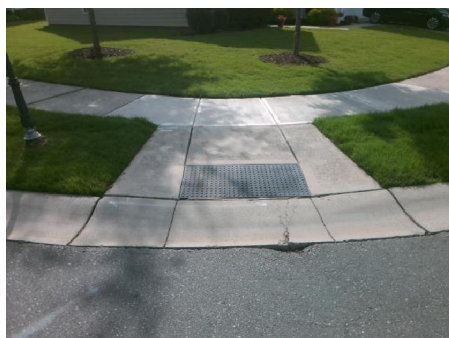
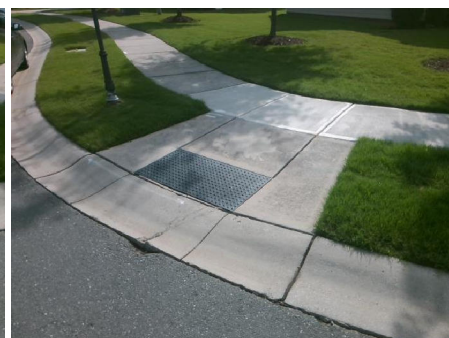
Not Found, R304.5.1, R304.2.2, R304.5.3

Compliance	Description	Data	Compliance	Description	Data
N/A	Ramp Length (in)	69.0	No	Ramp Slope (%)	8.4
No	Ramp Width (in)	45.0	No	Ramp XSlope (%)	3.1
N/A	Flare Type LT	N/A	N/A	Flare Type RT	N/A
N/A	Flare Slope LT (%)	N/A	N/A	Flare Slope RT (%)	N/A
N/A	Flare Traversable LT?	N/A	N/A	Flare Traversable RT?	N/A
N/A	Landing Length (in)	N/A	N/A	DWS Provided?	N/A
N/A	Landing Width (in)	N/A	N/A	DWS Contrast?	N/A
N/A	Landing Slope (%)	N/A	N/A	DWS Length (in)	N/A
N/A	Landing X Slope (%)	N/A	N/A	DWS Full Width?	N/A
N/A	Landing Curb? (Y/N)	N/A	N/A	DWS Offset (in)	N/A
N/A	Shared Landing?	N/A			
N/A	Gutter Ponding?	N/A	N/A	Gutter Slope (%)	N/A
N/A	Gutter Lip Ht (in)	2.0	N/A	Gutter X Slope (%)	N/A
N/A	Painted X Walk1?	No	N/A	Painted X Walk2?	No
	X Walk 1 Direction	To NW		X Walk 2 Direction	To SW
N/A	X Walk 1 Width (in)	N/A	N/A	X Walk 2 Width (in)	N/A
	X Walk 1 Slope (%)	1.8		X Walk 2 Slope (%)	1.2
	X Walk 1 X Slope (%)	0.8		X Walk 2 X Slope (%)	0.4

N/A	Ramp inside XWalk1?	N/A	N/A	Ramp inside XWalk2?	N/A
	Road Slope (%)	0.0	N/A	Clear Space?	N/A
	Road X Slope (%)	4.4	N/A	Clear Space to XWalk (in)	N/A
N/A	Any Obstructions?	N/A	N/A	Storm Grate/Utility Hazard?	N/A
	Obstruction Type			Storm Grate/Utility Type	
		N/A			N/A
			Yes	Surface Condition? (G/P)	Good

Remove & Replace Curb Ramp With Two New Directional Ramps or Equivalent.
