Access Compliance Report

Public Rights-of-Way

(Curb Ramps)

Intersection ID: 3683	Main Street: BROMPTON_LN	Cross Street: DAVIS_LAKE_PY	Location: SW
ADA ID: 98F7CF3C7485	Ramp Type: Perp	Initial Pass/Fail: Fail	Overall Compliance: No
		Severity Score: 10

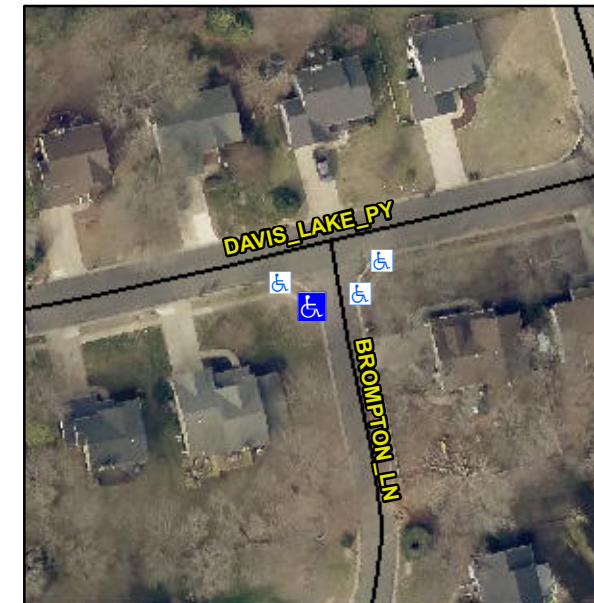
Not Found, R304.5.1, R304.5.3

Compliance	Description	Data	Compliance	Description	Data
N/A	Ramp Length (in)	51.0	Yes	Ramp Slope (%)	8.2
No	Ramp Width (in)	42.5	No	Ramp XSlope (%)	2.2
N/A	Flare Type LT	N/A	N/A	Flare Type RT	N/A
N/A	Flare Slope LT (%)	N/A	N/A	Flare Slope RT (%)	N/A
N/A	Flare Traversable LT?	N/A	N/A	Flare Traversable RT?	N/A
N/A	Landing Length (in)	N/A	N/A	DWS Provided?	N/A
N/A	Landing Width (in)	N/A	N/A	DWS Contrast?	N/A
N/A	Landing Slope (%)	N/A	N/A	DWS Length (in)	N/A
N/A	Landing X Slope (%)	N/A	N/A	DWS Full Width?	N/A
N/A	Landing Curb? (Y/N)	N/A	N/A	DWS Offset (in)	N/A
N/A	Shared Landing?	N/A			
N/A	Gutter Ponding?	N/A	N/A	Gutter Slope (%)	N/A
N/A	Gutter Lip Ht (in)	N/A	N/A	Gutter X Slope (%)	N/A
N/A	Painted X Walk1?	No	N/A	Painted X Walk2?	N/A
	X Walk 1 Direction	To E		X Walk 2 Direction	N/A
N/A	X Walk 1 Width (in)	N/A	N/A	X Walk 2 Width (in)	N/A
	X Walk 1 Slope (%)	0.8		X Walk 2 Slope (%)	N/A
	X Walk 1 X Slope (%)	2.2		X Walk 2 X Slope (%)	N/A

N/A	Ramp inside XWalk1?	N/A	N/A	Ramp inside XWalk2?	N/A
	Road Slope (%)	N/A	N/A	Clear Space?	N/A
	Road X Slope (%)	N/A	N/A	Clear Space to XWalk (in)	N/A
N/A	Any Obstructions?	N/A	N/A	Storm Grate/Utility Hazard?	N/A
	Obstruction Type			Storm Grate/Utility Type	
		N/A			N/A
			Yes	Surface Condition? (G/P)	Good

Remove & Replace Entire Ramp.
