Access Compliance Report

Public Rights-of-Way

(Curb Ramps)

Intersection ID: 18012	Main Street: RAMA_RD	Cross Street: CHARING_PL	Location: NE
ADA ID: 99022F088D82	Ramp Type: PerpDiag	Initial Pass/Fail: Fail	Overall Compliance: No
		Severity Score: 12.5

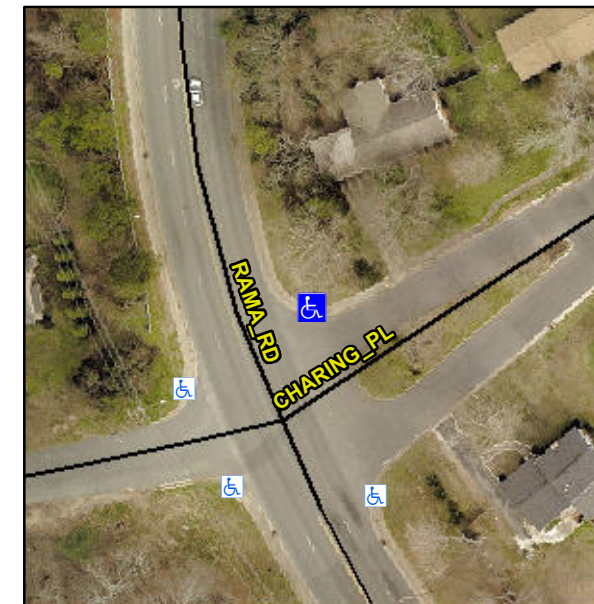
Not Found, R304.2.2

Compliance	Description	Data	Compliance	Description	Data
N/A	Ramp Length (in)	60.0	No	Ramp Slope (%)	9.9
Yes	Ramp Width (in)	48.0	Yes	Ramp XSlope (%)	1.4
N/A	Flare Type LT	N/A	N/A	Flare Type RT	N/A
N/A	Flare Slope LT (%)	N/A	N/A	Flare Slope RT (%)	N/A
N/A	Flare Traversable LT?	N/A	N/A	Flare Traversable RT?	N/A
N/A	Landing Length (in)	N/A	N/A	DWS Provided?	N/A
N/A	Landing Width (in)	N/A	N/A	DWS Contrast?	N/A
N/A	Landing Slope (%)	N/A	N/A	DWS Length (in)	N/A
N/A	Landing X Slope (%)	N/A	N/A	DWS Full Width?	N/A
N/A	Landing Curb? (Y/N)	N/A	N/A	DWS Offset (in)	N/A
N/A	Shared Landing?	N/A			
N/A	Gutter Ponding?	N/A	N/A	Gutter Slope (%)	N/A
N/A	Gutter Lip Ht (in)	N/A	N/A	Gutter X Slope (%)	N/A
N/A	Painted X Walk1?	No	N/A	Painted X Walk2?	No
	X Walk 1 Direction	To SW		X Walk 2 Direction	To S
N/A	X Walk 1 Width (in)	N/A	N/A	X Walk 2 Width (in)	N/A
	X Walk 1 Slope (%)	6.8		X Walk 2 Slope (%)	1.9
	X Walk 1 X Slope (%)	1.8		X Walk 2 X Slope (%)	6.8

N/A	Ramp inside XWalk1?	N/A	N/A	Ramp inside XWalk2?	N/A
	Road Slope (%)	1.8	N/A	Clear Space?	N/A
	Road X Slope (%)	5.4	N/A	Clear Space to XWalk (in)	N/A
N/A	Any Obstructions?	N/A	N/A	Storm Grate/Utility Hazard?	N/A
	Obstruction Type			Storm Grate/Utility Type	
		N/A			N/A
		Yes		Surface Condition? (G/P)	Good

Remove & Replace Curb Ramp With Two New Directional Ramps or Equivalent.
