Access Compliance Report

Public Rights-of-Way

(Curb Ramps)

Intersection ID: 52988	Main Street: LANDING_PLACE_LN	Cross Street: GREYTHORNE_DR	Location: NE
ADA ID: 990C4CA09C52	Ramp Type: BlendTrans1	Initial Pass/Fail: Fail	Overall Compliance: No
		Severity Score: 12.5

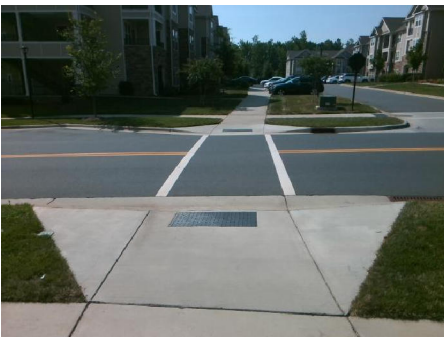
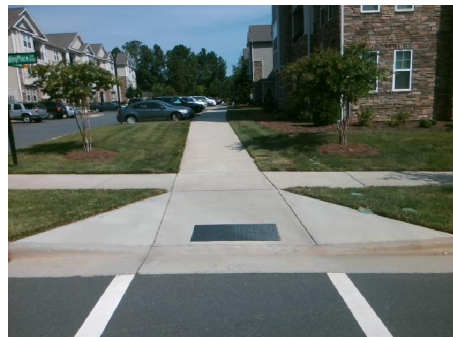
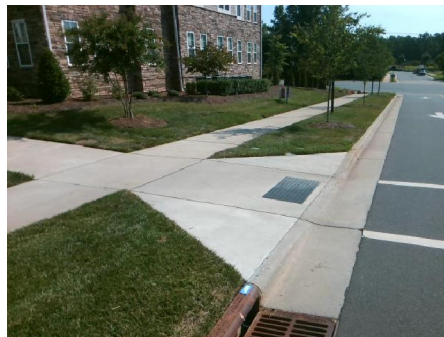
Not Found, R304.5.3

Compliance	Description	Data	Compliance	Description	Data
N/A	Ramp Length (in)	102.0	Yes	BlendTrans Slope (%)	4.3
Yes	Ramp Width (in)	84.0	No	BlendTrans XSlope (%)	5.3
N/A	Flare Type LT	N/A	N/A	Flare Type RT	N/A
N/A	Flare Slope LT (%)	N/A	N/A	Flare Slope RT (%)	N/A
N/A	Flare Traversable LT?	N/A	N/A	Flare Traversable RT?	N/A
N/A	Landing Length (in)	N/A	N/A	DWS Provided?	N/A
N/A	Landing Width (in)	N/A	N/A	DWS Contrast?	N/A
N/A	Landing Slope (%)	N/A	N/A	DWS Length (in)	N/A
N/A	Landing X Slope (%)	N/A	N/A	DWS Full Width?	N/A
N/A	Landing Curb? (Y/N)	N/A	N/A	DWS Offset (in)	N/A
N/A	Shared Landing?	N/A			
N/A	Gutter Ponding?	N/A	N/A	Gutter Slope (%)	N/A
N/A	Gutter Lip Ht (in)	N/A	N/A	Gutter X Slope (%)	N/A
N/A	Painted X Walk1?	Yes	N/A	Painted X Walk2?	N/A
	X Walk 1 Direction	To SE		X Walk 2 Direction	N/A
	X Walk 1 Width (in)	82.0		X Walk 2 Width (in)	N/A
	X Walk 1 Slope (%)	1.3		X Walk 2 Slope (%)	N/A
	X Walk 1 X Slope (%)	4.0		X Walk 2 X Slope (%)	N/A

N/A	Ramp inside XWalk1?	Yes	N/A	Ramp inside XWalk2?	N/A
	Road Slope (%)	4.0		Clear Space?	N/A
	Road X Slope (%)	1.3	N/A	Clear Space to XWalk (in)	N/A
N/A	Any Obstructions?	N/A	N/A	Storm Grate/Utility Hazard?	N/A
	Obstruction Type			Storm Grate/Utility Type	
		N/A			N/A
			Yes	Surface Condition? (G/P)	Good
			No	Curb Slope (%)	13.8

Possible Solutions:

Remove & Replace Curb Ramp With Two New Directional Ramps or Equivalent.
