Access Compliance Report

Public Rights-of-Way

(Curb Ramps)

Intersection ID: 13916	Main Street: CLANTON_RD	Cross Street: WEST_BV	Location: NE
ADA ID: 991251FC308E	Ramp Type: Perp	Initial Pass/Fail: Fail	Overall Compliance: No
		Severity Score: 25

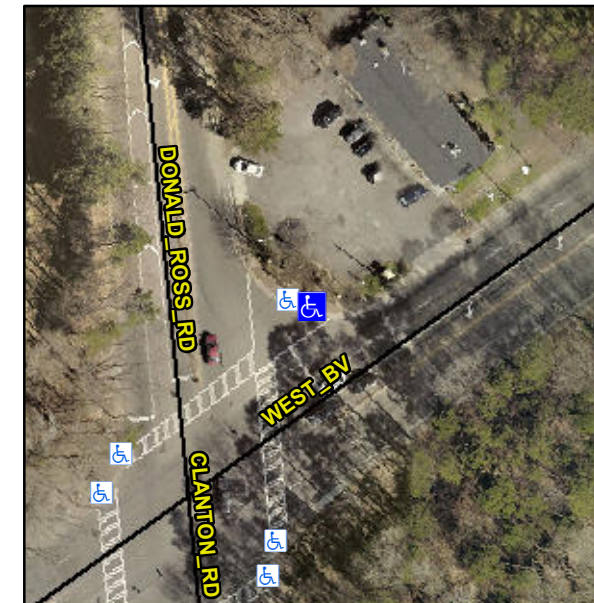
Compliance	Description	Data	Compliance	Description	Data
N/A	Ramp Length (in)	60.0	Yes	Ramp Slope (%)	8.0
Yes	Ramp Width (in)	48.0	No	Ramp XSlope (%)	9.2
N/A	Flare Type LT	N/A	N/A	Flare Type RT	N/A
N/A	Flare Slope LT (%)	N/A	N/A	Flare Slope RT (%)	N/A
N/A	Flare Traversable LT?	N/A	N/A	Flare Traversable RT?	N/A
N/A	Landing Length (in)	N/A	N/A	DWS Provided?	N/A
N/A	Landing Width (in)	N/A	N/A	DWS Contrast?	N/A
N/A	Landing Slope (%)	N/A	N/A	DWS Length (in)	N/A
N/A	Landing X Slope (%)	N/A	N/A	DWS Full Width?	N/A
N/A	Landing Curb? (Y/N)	N/A	N/A	DWS Offset (in)	N/A
N/A	Shared Landing?	N/A			
N/A	Gutter Ponding?	N/A	N/A	Gutter Slope (%)	N/A
N/A	Gutter Lip Ht (in)	N/A	N/A	Gutter X Slope (%)	N/A
N/A	Painted X Walk1?	Yes	N/A	Painted X Walk2?	N/A
	X Walk 1 Direction	To S		X Walk 2 Direction	N/A
N/A	X Walk 1 Width (in)	120.0	N/A	X Walk 2 Width (in)	N/A
	X Walk 1 Slope (%)	0.8		X Walk 2 Slope (%)	N/A
	X Walk 1 X Slope (%)	5.6		X Walk 2 X Slope (%)	N/A

N/A	Ramp inside XWalk1?	No	N/A	Ramp inside XWalk2?	N/A
	Road Slope (%)	N/A	N/A	Clear Space?	N/A
	Road X Slope (%)	N/A	N/A	Clear Space to XWalk (in)	N/A
N/A	Any Obstructions?	N/A	N/A	Storm Grate/Utility Hazard?	N/A
	Obstruction Type			Storm Grate/Utility Type	
		N/A			N/A
		Yes		Surface Condition? (G/P)	Good

**Remove & Replace Entire Ramp.
Restripe Crosswalk.**

R304.5.3

\$ 2050.00
