Access Compliance Report

Public Rights-of-Way

(Curb Ramps)

Intersection ID: 13736	Main Street: CAMDEN_RD	Cross Street: N/A	Location: SE
ADA ID: 9912688E5FFE	Ramp Type: BlendTrans2	Initial Pass/Fail: Fail	Overall Compliance: No
Severity Score: 1.25			
Codes/Mitigation Info/Possible Solution		Field Measurements/Component Compliance

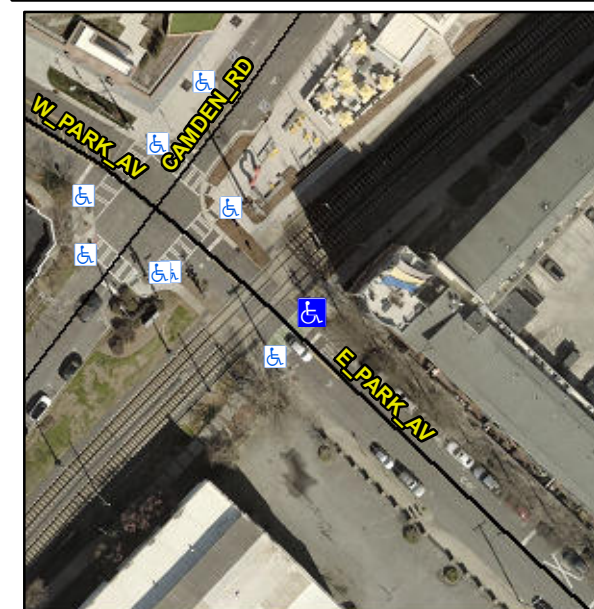
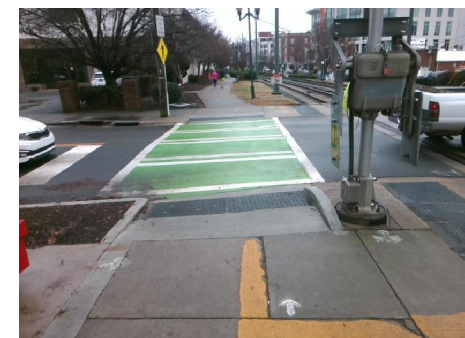
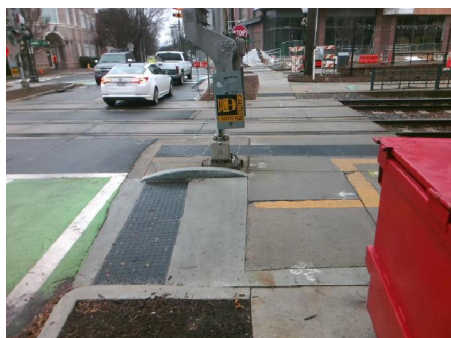
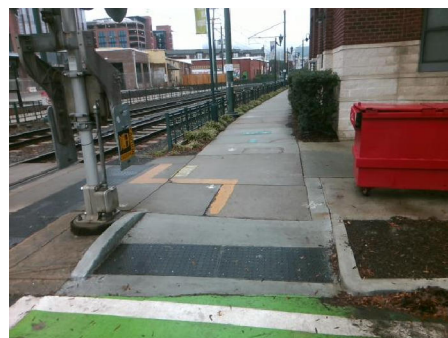
Compliance	Description	Data	Compliance	Description	Data
N/A	Ramp Length (in)	51.0	Yes	BlendTrans Slope (%)	2.2
Yes	Ramp Width (in)	95.0	No	BlendTrans XSlope (%)	5.0
N/A	Flare Type LT	N/A	N/A	Flare Type RT	N/A
N/A	Flare Slope LT (%)	N/A	N/A	Flare Slope RT (%)	N/A
N/A	Flare Traversable LT?	N/A	N/A	Flare Traversable RT?	N/A
N/A	Landing Length (in)	N/A	N/A	DWS Provided?	N/A
N/A	Landing Width (in)	N/A	N/A	DWS Contrast?	N/A
N/A	Landing Slope (%)	N/A	N/A	DWS Length (in)	N/A
N/A	Landing X Slope (%)	N/A	N/A	DWS Full Width?	N/A
N/A	Landing Curb? (Y/N)	N/A	N/A	DWS Offset (in)	N/A
N/A	Shared Landing?	N/A			
N/A	Gutter Ponding?	N/A	N/A	Gutter Slope (%)	N/A
N/A	Gutter Lip Ht (in)	N/A	N/A	Gutter X Slope (%)	N/A
N/A	Painted X Walk1?	Yes	N/A	Painted X Walk2?	N/A
	X Walk 1 Direction	To SW		X Walk 2 Direction	N/A
	X Walk 1 Width (in)	112.0		X Walk 2 Width (in)	N/A
	X Walk 1 Slope (%)	0.7		X Walk 2 Slope (%)	N/A
	X Walk 1 X Slope (%)	3.7		X Walk 2 X Slope (%)	N/A

N/A	Ramp inside XWalk1?	Yes	N/A	Ramp inside XWalk2?	N/A
	Road Slope (%)	3.7		Clear Space?	N/A
	Road X Slope (%)	0.7	N/A	Clear Space to XWalk (in)	N/A
N/A	Any Obstructions?	N/A	N/A	Storm Grate/Utility Hazard?	N/A
	Obstruction Type			Storm Grate/Utility Type	
		N/A			N/A
			Yes	Surface Condition? (G/P)	Good
			N/A	Curb Slope (%)	0.9

Possible Solutions:

Remove & Replace Curb Ramp With Two New Directional Ramps or Equivalent.
