Access Compliance Report

Public Rights-of-Way

(Curb Ramps)

Intersection ID: 43649	Main Street: FERGUSON_FOREST_DR	Cross Street: SWANN_BRANCH_DR	Location: SE
ADA ID: 991A4F40119E	Ramp Type: Perp	Initial Pass/Fail: Fail	Overall Compliance: No
Codes/Mitigation Info/Possible Solution		Field Measurements/Component Compliance	
Severity Score: 8.75

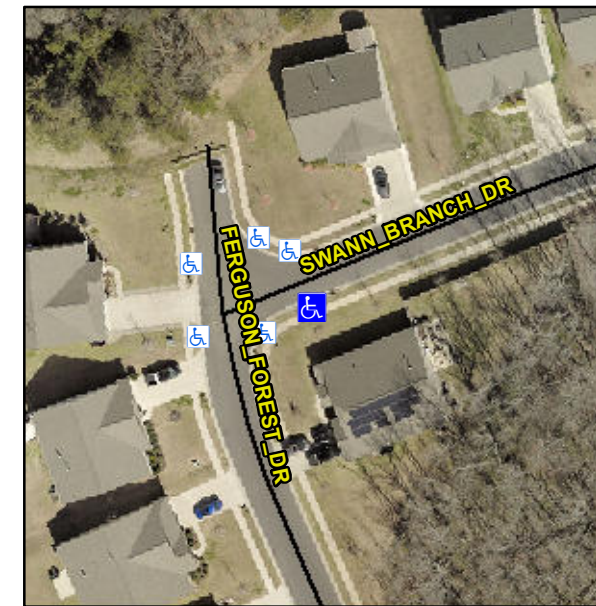
Not Found, R304.5.1

Compliance	Description	Data	Compliance	Description	Data
N/A	Ramp Length (in)	47.0	Yes	Ramp Slope (%)	6.7
No	Ramp Width (in)	47.0	Yes	Ramp XSlope (%)	0.5
N/A	Flare Type LT	N/A	N/A	Flare Type RT	N/A
N/A	Flare Slope LT (%)	N/A	N/A	Flare Slope RT (%)	N/A
N/A	Flare Traversable LT?	N/A	N/A	Flare Traversable RT?	N/A
N/A	Landing Length (in)	N/A	N/A	DWS Provided?	N/A
N/A	Landing Width (in)	N/A	N/A	DWS Contrast?	N/A
N/A	Landing Slope (%)	N/A	N/A	DWS Length (in)	N/A
N/A	Landing X Slope (%)	N/A	N/A	DWS Full Width?	N/A
N/A	Landing Curb? (Y/N)	N/A	N/A	DWS Offset (in)	N/A
N/A	Shared Landing?	N/A			
N/A	Gutter Ponding?	N/A	N/A	Gutter Slope (%)	N/A
N/A	Gutter Lip Ht (in)	N/A	N/A	Gutter X Slope (%)	N/A
N/A	Painted X Walk1?	No	N/A	Painted X Walk2?	N/A
	X Walk 1 Direction	To N		X Walk 2 Direction	N/A
N/A	X Walk 1 Width (in)	N/A	N/A	X Walk 2 Width (in)	N/A
	X Walk 1 Slope (%)	2.0		X Walk 2 Slope (%)	N/A
	X Walk 1 X Slope (%)	0.1		X Walk 2 X Slope (%)	N/A

N/A	Ramp inside XWalk1?	N/A	N/A	Ramp inside XWalk2?	N/A
	Road Slope (%)	N/A	N/A	Clear Space?	N/A
	Road X Slope (%)	N/A	N/A	Clear Space to XWalk (in)	N/A
N/A	Any Obstructions?	N/A	N/A	Storm Grate/Utility Hazard?	N/A
	Obstruction Type			Storm Grate/Utility Type	
		N/A			N/A
			Yes	Surface Condition? (G/P)	Good

Possible Solutions:

Remove & Replace Entire Ramp.
