Access Compliance Report

Public Rights-of-Way

(Curb Ramps)

| Intersection ID: 18000 | Main Street: PROVIDENCE_RD | Cross Street: ANDOVER_RD | Location: E |

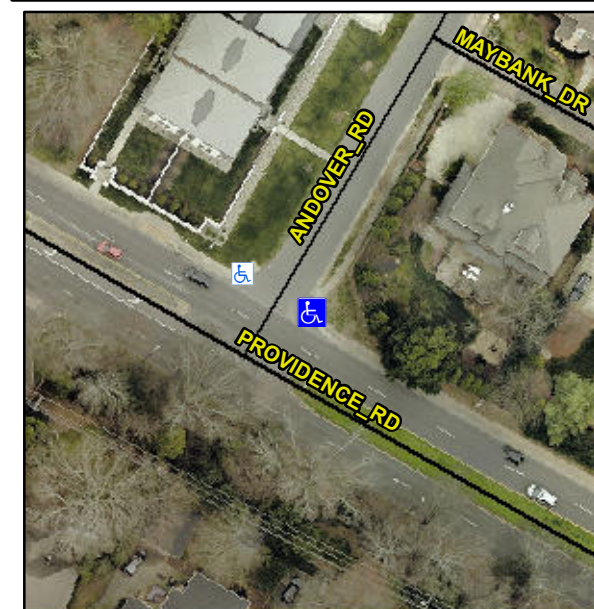
| ADA ID: 99312423C621 | Ramp Type: PerpDiag | Initial Pass/Fail: Fail | Overall Compliance: No |
| Severity Score: 31.25 | | | |

| Compliance | Description | Data | Compliance | Description | Data |
|---|---|---|---|---|---|
| N/A | Ramp Length (in) | 58.0 | No | Ramp Slope (%) | 11.4 |
| No | Ramp Width (in) | 35.0 | No | Ramp XSlope (%) | 4.2 |

Remove & Replace Curb Ramp With Two New Directional Ramps or Equivalent.

R304.5.1, R304.2.2, R304.5.3

Total Cost: \$ 3200.00
