# Access Compliance Report

## Public Rights-of-Way

### (Curb Ramps)

| Intersection ID: 18157 | Main Street: GILMORE_DR | Cross Street: MURRAYHILL_RD | Location: SW |

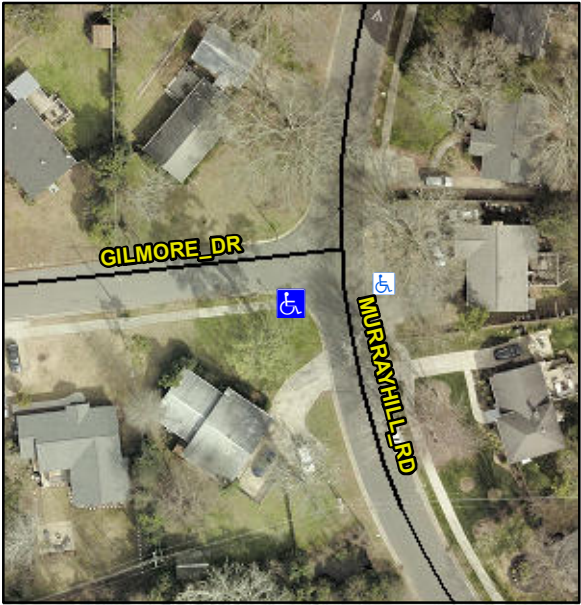
| ADA ID: 9933E77E31D6 | Ramp Type: Directional1 | Initial Pass/Fail: Fail | Overall Compliance: No |
| Severity Score: 12.5 | | | |

| <p>Surveyor Notes:</p> <p>N/A</p> <p>PROW/ADA:</p> <p>R304.2.2</p> | | | Compliance | Description | Data |
| | | | No | Ramp Slope (%) | 10.8 |

| | Possible Solutions: | | | | |
| | Remove & Replace Entire Ramp. | | | | |
