# Access Compliance Report

## Public Rights-of-Way

### (Curb Ramps)

Intersection ID: 8710	Main Street: EASTBROOK_RD	Cross Street: MILPORT_PL	Location: SE
ADA ID: 99395F45F29A	Ramp Type: BlendTrans1	Initial Pass/Fail: Fail	Overall Compliance: No
Severity Score: 10			
Codes/Mitigation Info/Possible Solution		Field Measurements/Component Compliance

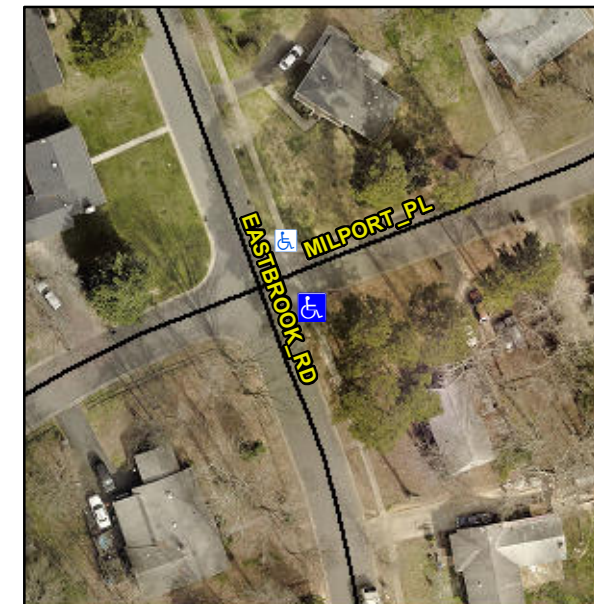
**Not Found, R304.5.1, R304.5.3**

Compliance	Description	Data	Compliance	Description	Data
N/A	Ramp Length (in)	65.0	Yes	BlendTrans Slope (%)	2.6
No	Ramp Width (in)	47.0	No	BlendTrans XSlope (%)	3.1
N/A	Flare Type LT	N/A	N/A	Flare Type RT	N/A
N/A	Flare Slope LT (%)	N/A	N/A	Flare Slope RT (%)	N/A
N/A	Flare Traversable LT?	N/A	N/A	Flare Traversable RT?	N/A
N/A	Landing Length (in)	N/A	N/A	DWS Provided?	N/A
N/A	Landing Width (in)	N/A	N/A	DWS Contrast?	N/A
N/A	Landing Slope (%)	N/A	N/A	DWS Length (in)	N/A
N/A	Landing X Slope (%)	N/A	N/A	DWS Full Width?	N/A
N/A	Landing Curb? (Y/N)	N/A	N/A	DWS Offset (in)	N/A
N/A	Shared Landing?	N/A			
N/A	Gutter Ponding?	N/A	N/A	Gutter Slope (%)	N/A
N/A	Gutter Lip Ht (in)	1.0	N/A	Gutter X Slope (%)	N/A
N/A	Painted X Walk1?	No	N/A	Painted X Walk2?	N/A
	X Walk 1 Direction	To NW		X Walk 2 Direction	N/A
	X Walk 1 Width (in)	N/A		X Walk 2 Width (in)	N/A
	X Walk 1 Slope (%)	1.2		X Walk 2 Slope (%)	N/A
	X Walk 1 X Slope (%)	0.8		X Walk 2 X Slope (%)	N/A

N/A	Ramp inside XWalk1?	N/A	N/A	Ramp inside XWalk2?	N/A
	Road Slope (%)	0.8		Clear Space?	N/A
	Road X Slope (%)	1.2	N/A	Clear Space to XWalk (in)	N/A
N/A	Any Obstructions?	N/A	N/A	Storm Grate/Utility Hazard?	N/A
	Obstruction Type			Storm Grate/Utility Type	
		N/A			N/A
			Yes	Surface Condition? (G/P)	Good
			No	Curb Slope (%)	18.1

**Remove & Replace Curb Ramp With Two New Directional Ramps or Equivalent.**
