# Access Compliance Report

### (Curb Ramps)

| Intersection ID: 14844 | Main Street: DILWORTH RD WEST | Cross Street: EAST BV | Location: NE |
| ADA ID: 993B60D48C0E | Ramp Type: Directional1 | Initial Pass/Fail: Pass | Overall Compliance: No |

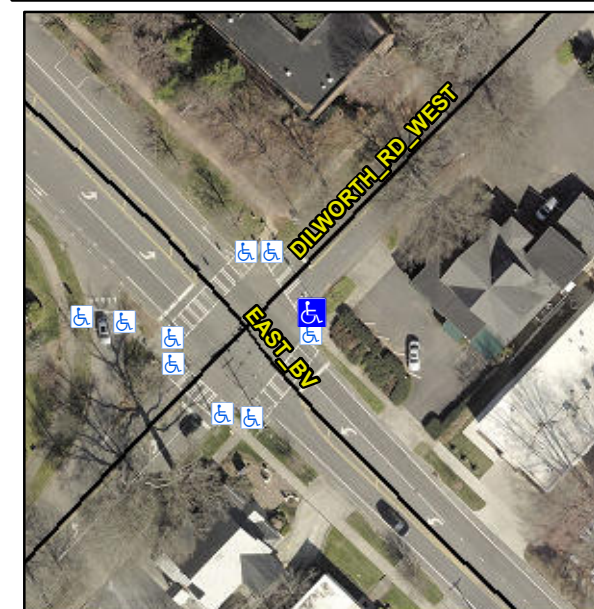
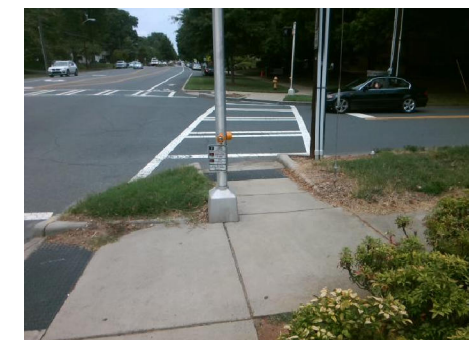
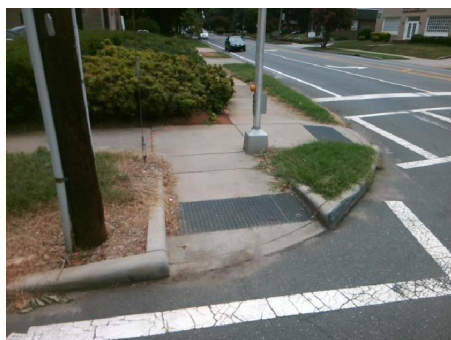
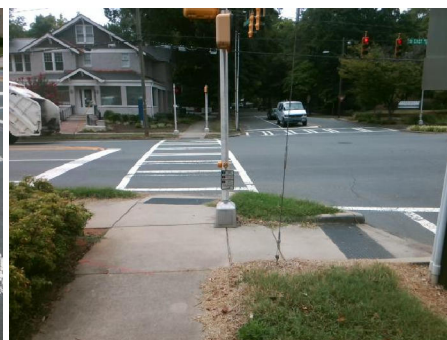
| Severity Score: 7.5 | | | |

**R302.7.2**

| Compliance | Description | Data | Compliance | Description | Data |
|---|---|---|---|---|---|
| No | Gutter Lip Ht (in) | 0.5 | Yes | Gutter X Slope (%) | 1.0 |

**Grind Gutter Lip.**

\$ 200.00
