# Access Compliance Report

## Public Rights-of-Way (Curb Ramps)

| Intersection ID: 11231 | Main Street: W_4TH_ST_EXT | Cross Street: WALNUT_AV | Location: | N |
| ADA ID: 994DFE13A0DC | Ramp Type: Directional1 | Initial Pass/Fail: Pass | Overall Compliance: No | Severity Score: 0.25 |

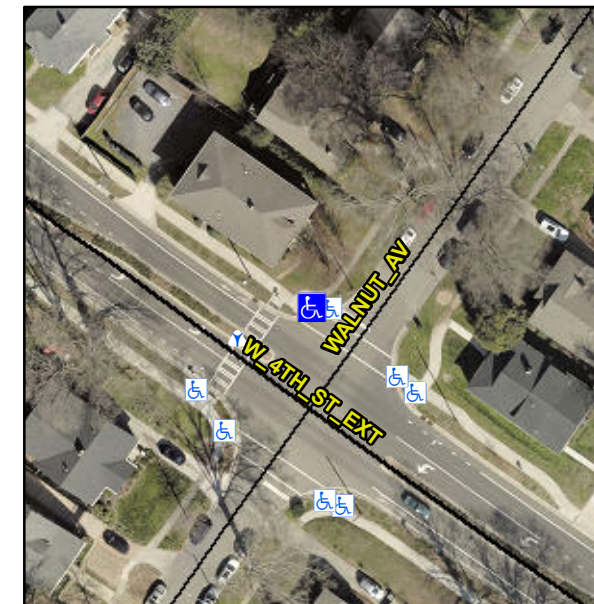
**R304.5.3, R304.5.2**

| Compliance | Description | Data | Compliance | Description | Data |
|---|---|---|---|---|---|
| No | Ramp XSlope (%) | 3.0 | | | |
| No | Landing X Slope (%) | 3.6 | Yes | DWS Full Width? | Yes |
| Yes | Gutter Lip Ht (in) | 0.0 | No | Gutter X Slope (%) | 2.9 |

**Remove & Replace Entire Ramp.  
Remove & Replace Gutter.**

Total Cost: \$ 2350.00
