Access Compliance Report

Public Rights-of-Way

(Curb Ramps)

Intersection ID: 18216	Main Street: FOREST_DR	Cross Street: S_WENDOVER_RD	Location:	N
ADA ID: 9969E3D5344A	Ramp Type: PerpDiag	Initial Pass/Fail: Fail	Overall Compliance: No	Severity Score: 12.5

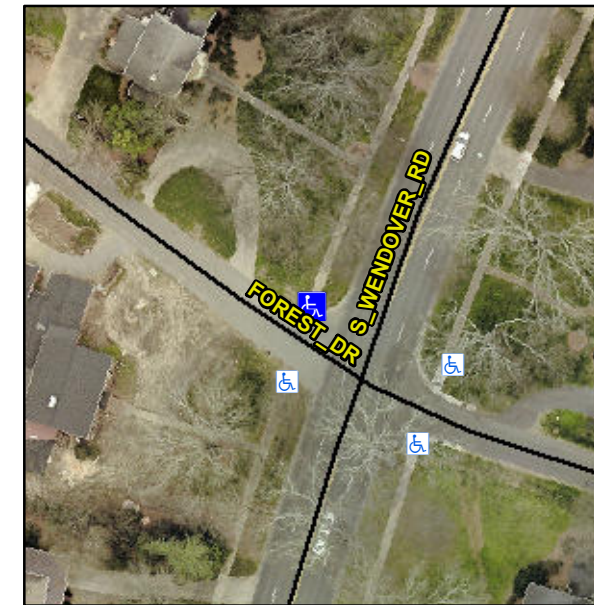
Not Found, R304.2.2

Compliance	Description	Data	Compliance	Description	Data
N/A	Ramp Length (in)	63.0	No	Ramp Slope (%)	8.9
Yes	Ramp Width (in)	48.0	Yes	Ramp XSlope (%)	1.1
N/A	Flare Type LT	N/A	N/A	Flare Type RT	N/A
N/A	Flare Slope LT (%)	N/A	N/A	Flare Slope RT (%)	N/A
N/A	Flare Traversable LT?	N/A	N/A	Flare Traversable RT?	N/A
N/A	Landing Length (in)	N/A	N/A	DWS Provided?	N/A
N/A	Landing Width (in)	N/A	N/A	DWS Contrast?	N/A
N/A	Landing Slope (%)	N/A	N/A	DWS Length (in)	N/A
N/A	Landing X Slope (%)	N/A	N/A	DWS Full Width?	N/A
N/A	Landing Curb? (Y/N)	N/A	N/A	DWS Offset (in)	N/A
N/A	Shared Landing?	N/A			
N/A	Gutter Ponding?	N/A	N/A	Gutter Slope (%)	N/A
N/A	Gutter Lip Ht (in)	N/A	N/A	Gutter X Slope (%)	N/A
N/A	Painted X Walk1?	No	N/A	Painted X Walk2?	No
	X Walk 1 Direction	To SW		X Walk 2 Direction	To SE
N/A	X Walk 1 Width (in)	N/A	N/A	X Walk 2 Width (in)	N/A
	X Walk 1 Slope (%)	2.8		X Walk 2 Slope (%)	2.4
	X Walk 1 X Slope (%)	2.0		X Walk 2 X Slope (%)	1.8

N/A	Ramp inside XWalk1?	N/A	N/A	Ramp inside XWalk2?	N/A
	Road Slope (%)	1.9	N/A	Clear Space?	N/A
	Road X Slope (%)	1.8	N/A	Clear Space to XWalk (in)	N/A
N/A	Any Obstructions?	N/A	N/A	Storm Grate/Utility Hazard?	N/A
	Obstruction Type			Storm Grate/Utility Type	
		N/A			N/A
			Yes	Surface Condition? (G/P)	Good

Remove & Replace Curb Ramp With Two New Directional Ramps or Equivalent.
