Access Compliance Report

Public Rights-of-Way

(Curb Ramps)

Intersection ID: 10031842	Main Street: MINTWORTH_AV	Cross Street: N/A	Location: NW
ADA ID: 9970274BD0B4	Ramp Type: Perp	Initial Pass/Fail: Fail	Overall Compliance: No Severity Score: 21.25

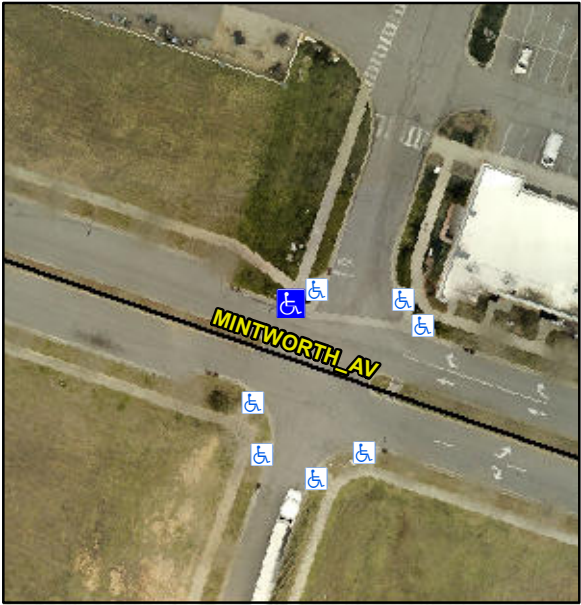
Possible Solutions:		Compliance	Description	Data
	Remove & Replace Entire Ramp.		No	Ramp Length (in)	79.0
			No	Ramp Width (in)	44.0
			N/A	Flare Type LT	N/A
			N/A	Flare Slope LT (%)	N/A
			N/A	Flare Traversable LT?	N/A
			N/A	Landing Length (in)	N/A
			N/A	Landing Width (in)	N/A
			N/A	Landing Slope (%)	N/A
			N/A	Landing X Slope (%)	N/A
<p>Surveyor Notes:</p> <p>N/A</p> <p>PROW/ADA:</p> <p>R304.5.1, R304.2.2</p>			N/A	Flare Type RT	N/A
			N/A	Flare Slope RT (%)	N/A
			N/A	Flare Traversable RT?	N/A
			N/A	DWS Provided?	N/A
			N/A	DWS Contrast?	N/A
			N/A	DWS Length (in)	N/A
			N/A	DWS Full Width?	N/A
			N/A	DWS Offset (in)	N/A
			N/A	Shared Landing?	N/A
			N/A	Gutter Ponding?	N/A
			N/A	Gutter Lip Ht (in)	N/A
			N/A	Painted X Walk1?	No
				X Walk 1 Direction	To SW
			N/A	X Walk 1 Width (in)	N/A
				X Walk 1 Slope (%)	1.4
				X Walk 1 X Slope (%)	1.6

N/A	Ramp inside XWalk1?	N/A
			N/A	Road Slope (%)	N/A
			N/A	Road X Slope (%)	N/A
			N/A	Any Obstructions?	N/A
Total Cost:		\$ 1850.00		Obstruction Type	
			N/A		N/A
			Yes	Surface Condition? (G/P)	Good
