# Access Compliance Report

## Public Rights-of-Way

| Intersection ID: 27188 | Main Street: BALLANTYNE COMMONS PY | Cross Street: QUAIL ACRES RD | Location: NE |
| ADA ID: 997BB87A590F | Ramp Type: PerpDiag | Initial Pass/Fail: Pass | Overall Compliance: No |

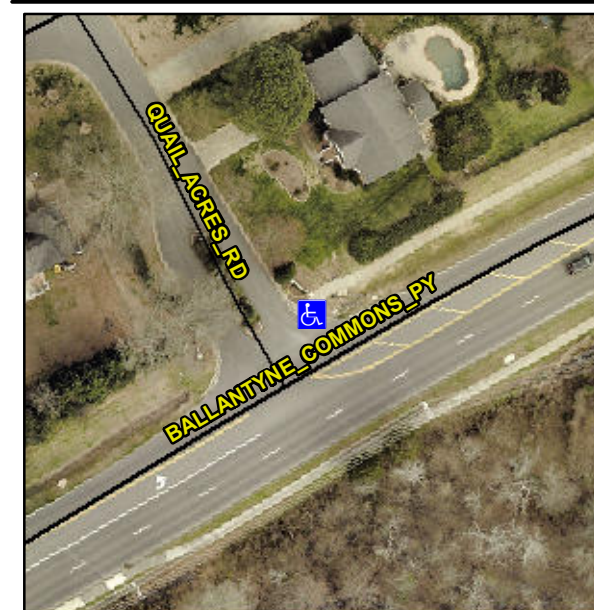
**R304.5.3, R304.2.1, R302.7, R302.7.2, R304.5.4**

| Compliance | Description | Data | Compliance | Description | Data |
| Yes | Ramp Width (in) | 48.0 | No | Ramp XSlope (%) | 2.4 |
| No | Landing Length (in) | 36.5 | Yes | DWS Provided? | Yes |
| No | Gutter Ponding? | Yes | No | Gutter Slope (%) | 9.5 |
| No | Gutter Lip Ht (in) | 0.5 | No | Gutter X Slope (%) | 2.6 |

**Remove & Replace Curb Ramp With Two New Directional Ramps or Equivalent. Remove & Replace Gutter.**
