# Access Compliance Report

## Public Rights-of-Way

### (Curb Ramps)

Intersection ID: N/A	Main Street: REA_RD	Cross Street: N/A	Location: NE
ADA ID: 998A516DC3D7	Ramp Type: Perp	Initial Pass/Fail: Fail	Overall Compliance: No
Severity Score: 21.25			
Codes/Mitigation Info/Possible Solution		Field Measurements/Component Compliance

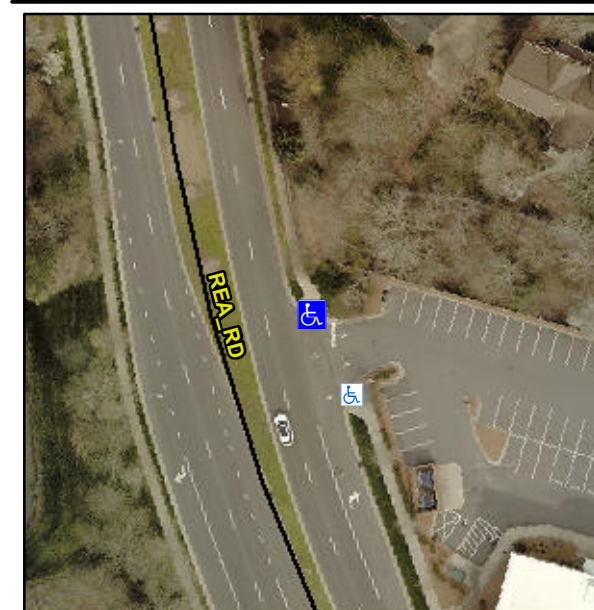
**Not Found, R304.5.1, R304.5.3**

Compliance	Description	Data	Compliance	Description	Data
N/A	Ramp Length (in)	65.0	Yes	Ramp Slope (%)	7.5
No	Ramp Width (in)	47.5	No	Ramp XSlope (%)	5.5
N/A	Flare Type LT	N/A	N/A	Flare Type RT	N/A
N/A	Flare Slope LT (%)	N/A	N/A	Flare Slope RT (%)	N/A
N/A	Flare Traversable LT?	N/A	N/A	Flare Traversable RT?	N/A
N/A	Landing Length (in)	N/A	N/A	DWS Provided?	N/A
N/A	Landing Width (in)	N/A	N/A	DWS Contrast?	N/A
N/A	Landing Slope (%)	N/A	N/A	DWS Length (in)	N/A
N/A	Landing X Slope (%)	N/A	N/A	DWS Full Width?	N/A
N/A	Landing Curb? (Y/N)	N/A	N/A	DWS Offset (in)	N/A
N/A	Shared Landing?	N/A			
N/A	Gutter Ponding?	N/A	N/A	Gutter Slope (%)	N/A
N/A	Gutter Lip Ht (in)	N/A	N/A	Gutter X Slope (%)	N/A
N/A	Painted X Walk1?	No	N/A	Painted X Walk2?	N/A
	X Walk 1 Direction	To S		X Walk 2 Direction	N/A
N/A	X Walk 1 Width (in)	N/A	N/A	X Walk 2 Width (in)	N/A
	X Walk 1 Slope (%)	1.2		X Walk 2 Slope (%)	N/A
	X Walk 1 X Slope (%)	0.3		X Walk 2 X Slope (%)	N/A

N/A	Ramp inside XWalk1?	N/A	N/A	Ramp inside XWalk2?	N/A
	Road Slope (%)	N/A	N/A	Clear Space?	N/A
	Road X Slope (%)	N/A	N/A	Clear Space to XWalk (in)	N/A
N/A	Any Obstructions?	N/A	N/A	Storm Grate/Utility Hazard?	N/A
	Obstruction Type			Storm Grate/Utility Type	
		N/A			N/A
			Yes	Surface Condition? (G/P)	Good

Possible Solutions:

**Remove & Replace Entire Ramp.**

Total Cost: \$ 1850.00
