# Access Compliance Report

## Public Rights-of-Way

### (Curb Ramps)

Intersection ID: 9622	Main Street: FAIRFIELD_ST	Cross Street: WASHINGTON_AV	Location: SW
ADA ID: 9992ABC5BAA7	Ramp Type: Perp	Initial Pass/Fail: Fail	Overall Compliance: No
		Severity Score: 12.5

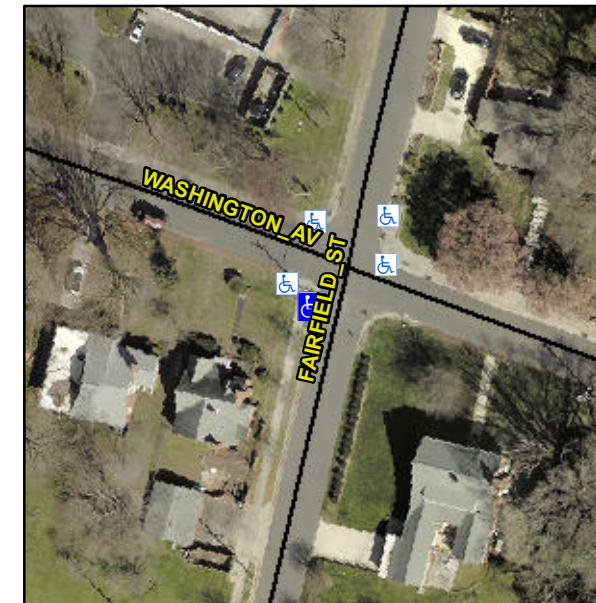
**Not Found, R304.2.2**

Compliance	Description	Data	Compliance	Description	Data
N/A	Ramp Length (in)	59.8	No	Ramp Slope (%)	9.4
Yes	Ramp Width (in)	59.0	Yes	Ramp XSlope (%)	0.9
N/A	Flare Type LT	N/A	N/A	Flare Type RT	N/A
N/A	Flare Slope LT (%)	N/A	N/A	Flare Slope RT (%)	N/A
N/A	Flare Traversable LT?	N/A	N/A	Flare Traversable RT?	N/A
N/A	Landing Length (in)	N/A	N/A	DWS Provided?	N/A
N/A	Landing Width (in)	N/A	N/A	DWS Contrast?	N/A
N/A	Landing Slope (%)	N/A	N/A	DWS Length (in)	N/A
N/A	Landing X Slope (%)	N/A	N/A	DWS Full Width?	N/A
N/A	Landing Curb? (Y/N)	N/A	N/A	DWS Offset (in)	N/A
N/A	Shared Landing?	N/A			
N/A	Gutter Ponding?	N/A	N/A	Gutter Slope (%)	N/A
N/A	Gutter Lip Ht (in)	N/A	N/A	Gutter X Slope (%)	N/A
N/A	Painted X Walk1?	No	N/A	Painted X Walk2?	N/A
	X Walk 1 Direction	To E		X Walk 2 Direction	N/A
N/A	X Walk 1 Width (in)	N/A	N/A	X Walk 2 Width (in)	N/A
	X Walk 1 Slope (%)	0.6		X Walk 2 Slope (%)	N/A
	X Walk 1 X Slope (%)	0.2		X Walk 2 X Slope (%)	N/A

N/A	Ramp inside XWalk1?	N/A	N/A	Ramp inside XWalk2?	N/A
	Road Slope (%)	0.2	N/A	Clear Space?	N/A
	Road X Slope (%)	0.6	N/A	Clear Space to XWalk (in)	N/A
N/A	Any Obstructions?	N/A	N/A	Storm Grate/Utility Hazard?	N/A
	Obstruction Type			Storm Grate/Utility Type	
		N/A			N/A
		Yes		Surface Condition? (G/P)	Good

**Remove & Replace Entire Ramp.**

Total Cost: \$ 1850.00
