# Access Compliance Report

## Public Rights-of-Way

### (Curb Ramps)

Intersection ID: 10040250	Main Street: VAIL_AV	Cross Street: N/A	Location:	N
ADA ID: 99A4056C0BA6	Ramp Type: PerpDiag	Initial Pass/Fail: Fail	Overall Compliance: No	Severity Score: 37.5

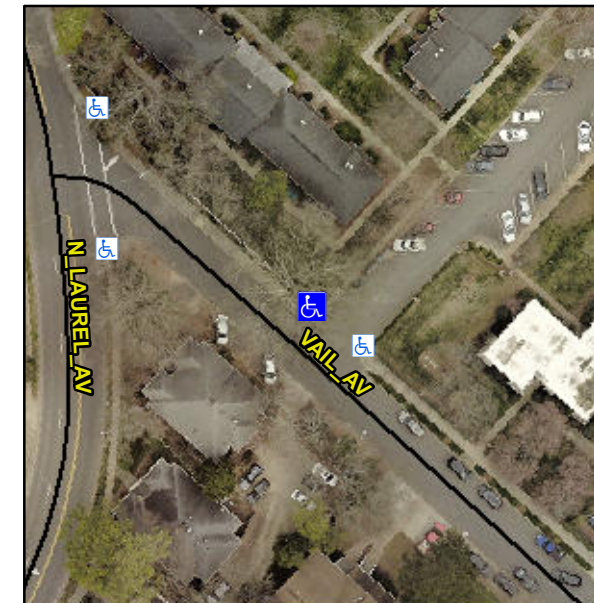
**Not Found, R304.2.2, R304.5.3**

Compliance	Description	Data	Compliance	Description	Data
N/A	Ramp Length (in)	61.0	No	Ramp Slope (%)	13.0
Yes	Ramp Width (in)	49.0	No	Ramp XSlope (%)	6.2
N/A	Flare Type LT	N/A	N/A	Flare Type RT	N/A
N/A	Flare Slope LT (%)	N/A	N/A	Flare Slope RT (%)	N/A
N/A	Flare Traversable LT?	N/A	N/A	Flare Traversable RT?	N/A
N/A	Landing Length (in)	N/A	N/A	DWS Provided?	N/A
N/A	Landing Width (in)	N/A	N/A	DWS Contrast?	N/A
N/A	Landing Slope (%)	N/A	N/A	DWS Length (in)	N/A
N/A	Landing X Slope (%)	N/A	N/A	DWS Full Width?	N/A
N/A	Landing Curb? (Y/N)	N/A	N/A	DWS Offset (in)	N/A
N/A	Shared Landing?	N/A			
N/A	Gutter Ponding?	N/A	N/A	Gutter Slope (%)	N/A
N/A	Gutter Lip Ht (in)	N/A	N/A	Gutter X Slope (%)	N/A
N/A	Painted X Walk1?	No	N/A	Painted X Walk2?	No
	X Walk 1 Direction	To SW		X Walk 2 Direction	To SE
N/A	X Walk 1 Width (in)	N/A	N/A	X Walk 2 Width (in)	N/A
	X Walk 1 Slope (%)	1.8		X Walk 2 Slope (%)	0.7
	X Walk 1 X Slope (%)	0.3		X Walk 2 X Slope (%)	2.1

N/A	Ramp inside XWalk1?	N/A	N/A	Ramp inside XWalk2?	N/A
	Road Slope (%)	2.2	N/A	Clear Space?	N/A
	Road X Slope (%)	1.5	N/A	Clear Space to XWalk (in)	N/A
N/A	Any Obstructions?	N/A	N/A	Storm Grate/Utility Hazard?	N/A
	Obstruction Type			Storm Grate/Utility Type	
		N/A			N/A
			Yes	Surface Condition? (G/P)	Good

**Remove & Replace Curb Ramp With Two New Directional Ramps or Equivalent.**
