Access Compliance Report Public Rights-of-Way (Curb Ramps)

Intersection ID: 10759	Main Street: SPRATT_ST	Cross Street: OLIVER_ST	Location: E
ADA ID: 99A76BD3A13B	Ramp Type: MedianPerp	Initial Pass/Fail: Fail	Overall Compliance: No Severity Score: 21.25

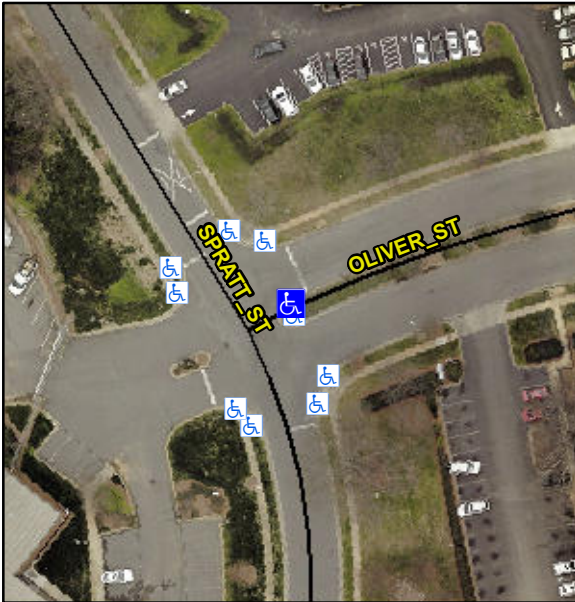
Not Found, R304.5.1, R304.2.2

Compliance	Description	Data	Compliance	Description	Data
N/A	Ramp Length (in)	60.0	No	Ramp Slope (%)	9.0
No	Ramp Width (in)	40.5	Yes	Ramp XSlope (%)	0.9
N/A	Flare Type LT	N/A	N/A	Flare Type RT	N/A
N/A	Flare Slope LT (%)	N/A	N/A	Flare Slope RT (%)	N/A
N/A	Flare Traversable LT?	N/A	N/A	Flare Traversable RT?	N/A
N/A	Landing Length (in)	N/A	N/A	DWS Provided?	N/A
N/A	Landing Width (in)	N/A	N/A	DWS Contrast?	N/A
N/A	Landing Slope (%)	N/A	N/A	DWS Length (in)	N/A
N/A	Landing X Slope (%)	N/A	N/A	DWS Full Width?	N/A
N/A	Landing Curb? (Y/N)	N/A	N/A	DWS Offset (in)	N/A
N/A	Shared Landing?	N/A			
N/A	Gutter Ponding?	N/A	N/A	Gutter Slope (%)	N/A
N/A	Gutter Lip Ht (in)	1.0	N/A	Gutter X Slope (%)	N/A
N/A	Painted X Walk1?	No	N/A	Painted X Walk2?	N/A
	X Walk 1 Direction	To S		X Walk 2 Direction	N/A
N/A	X Walk 1 Width (in)	N/A	N/A	X Walk 2 Width (in)	N/A
	X Walk 1 Slope (%)	0.6		X Walk 2 Slope (%)	N/A
	X Walk 1 X Slope (%)	1.3		X Walk 2 X Slope (%)	N/A

N/A	Ramp inside XWalk1?	N/A	N/A	Ramp inside XWalk2?	N/A
	Road Slope (%)	N/A	N/A	Clear Space?	N/A
	Road X Slope (%)	N/A	N/A	Clear Space to XWalk (in)	N/A
N/A	Any Obstructions?	N/A	N/A	Storm Grate/Utility Hazard?	N/A
	Obstruction Type			Storm Grate/Utility Type	
		N/A			N/A
			Yes	Surface Condition? (G/P)	Good

Remove & Replace Entire Ramp.
