Access Compliance Report

Public Rights-of-Way

(Curb Ramps)

Intersection ID: 10012995	Main Street: IVEY_DR	Cross Street: N/A	Location: W
ADA ID: 99AD27C51D49	Ramp Type: Perp	Initial Pass/Fail: Fail	Overall Compliance: No
			Severity Score: 58.75

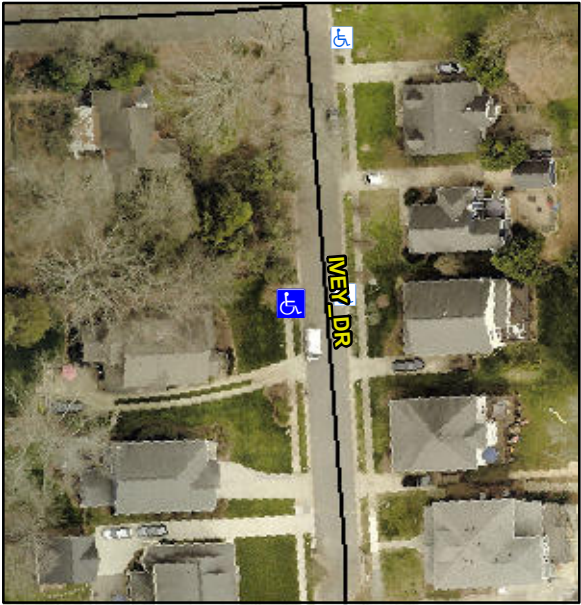
Possible Solutions:		Compliance	Description	Data
	Remove & Replace Entire Ramp.		No	Ramp Length (in)	47.0
			No	Ramp Width (in)	47.5
			N/A	Flare Type LT	N/A
			N/A	Flare Slope LT (%)	N/A
			N/A	Flare Traversable LT?	N/A
			N/A	Landing Length (in)	N/A
			N/A	Landing Width (in)	N/A
			N/A	Landing Slope (%)	N/A
			N/A	Landing X Slope (%)	N/A
<p>Surveyor Notes:</p> <p>N/A</p> <p>PROW/ADA:</p> <p>Not Found, R304.5.1, R304.2.2, R304.5.3</p>			N/A	Flare Type RT	N/A
			N/A	Flare Slope RT (%)	N/A
			N/A	Flare Traversable RT?	N/A
			N/A	DWS Provided?	N/A
			N/A	DWS Contrast?	N/A
			N/A	DWS Length (in)	N/A
			N/A	DWS Full Width?	N/A
			N/A	DWS Offset (in)	N/A
			N/A	Gutter Ponding?	N/A
			N/A	Gutter Lip Ht (in)	N/A
<p>Total Cost:</p> <p>\$ 1850.00</p>			No	Painted X Walk2?	N/A
			To E	X Walk 2 Direction	N/A
			N/A	X Walk 2 Width (in)	N/A

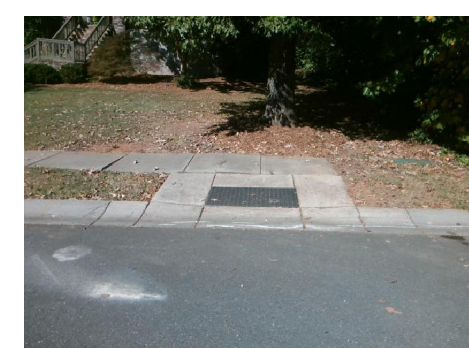
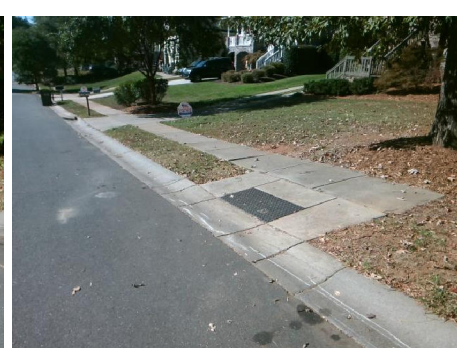
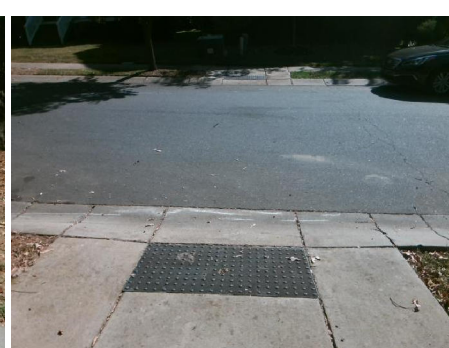
2.0	X Walk 2 Slope (%)	N/A
			7.4	X Walk 2 X Slope (%)	N/A
			N/A	Ramp inside XWalk2?	N/A
			N/A	Clear Space?	N/A
			N/A	Clear Space to XWalk (in)	N/A
			N/A	Storm Grate/Utility Hazard?	N/A
			N/A	Storm Grate/Utility Type	N/A
			N/A	Obstruction Type	N/A
			Yes	Surface Condition? (G/P)	Good
