## **Access Compliance Report Public Rights-of-Way** (Curb Ramps)

Intersection ID: N/A Main Street: MILLENNIUM AV Cross Street: POTOMAC RIVER PY Location: SW **Overall Compliance: No Severity Score:** 12.5 **ADA ID: 99AED2C51C86** Ramp Type: Directional1 Initial Pass/Fail: Fail

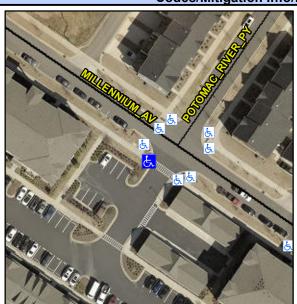
Compliance Description Data Compliance Description Data 125.0 N/A Grade Break? N/A Ramp Length (in) N/A 68.0 N/A Yes Ramp Width (in) Grade Break Slope (%) 0.0 N/A No Ramp Slope (%) 10.1 Grade Break XSlope (%) 0.0 Ramp XSlope (%) 1.4 Flare Type LT N/A N/A Flare Type RT N/A Flare Slope LT (%) N/A N/A Flare Slope RT (%) 0.0 Flare Traversable LT? N/A N/A Flare Traversable RT? N/A 0.0 N/A DWS Provided? Landing Length (in) N/A N/A **DWS Contrast?** Landing Width (in) 0.0 N/A Landing Slope (%) 0.0 N/A DWS Length (in) N/A 0.0 N/A DWS Full Width? Landing X Slope (%) N/A Landing Curb? (Y/N) N/A N/A DWS Offset LT (in) N/A Shared Landing? N/A N/A DWS Offset RT (in) N/A **Gutter Ponding?** 0.0 N/A Gutter Slope (%) N/A Gutter Lip Ht (in) 0.0 N/A Gutter X Slope (%) N/A Painted X Walk1? Road Slope (%) Yes 5.4 To SE X Walk 1 Direction Road X Slope (%) 2.2 X Walk 1 Width (in) 72.0 Clear Space? N/A X Walk 1 Slope (%) 5.4 N/A N/A Clear Space to XWalk (in) X Walk 1 X Slope (%) 2.2 N/A Storm Grate/Utility Hazard? N/A Yes Ramp inside XWalk1? Storm Grate/Utility Type N/A Any Obstructions? N/A **Obstruction Type** Surface Condition? (G/P) Yes Good N/A N/A Curb Slope (%) 7.5

Remove & Replace Entire Ramp. Surveyor Notes: N/A PROW/ADA: R304.2.2
