Access Compliance Report

Public Rights-of-Way

(Curb Ramps)

Intersection ID: 5967	Main Street: N_TRYON_ST	Cross Street: MCCULLOUGH_DR	Location: NW
ADA ID: 99AFB155639A	Ramp Type: Perp	Initial Pass/Fail: Pass	Overall Compliance: No
Severity Score: 15.25			
Codes/Mitigation Info/Possible Solution		Field Measurements/Component Compliance

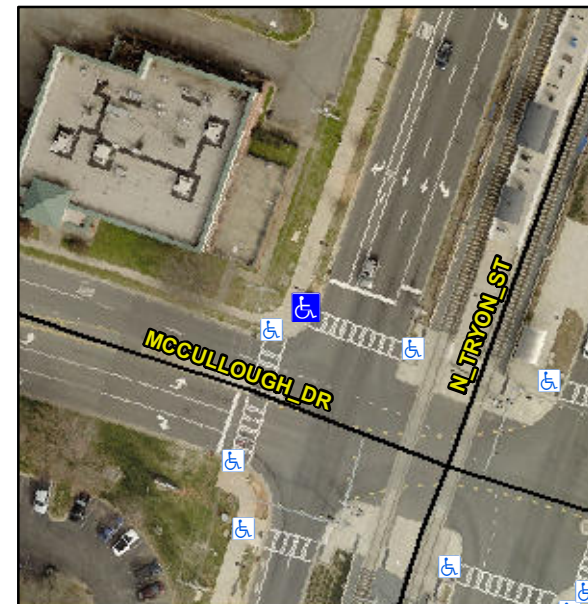
Not Found, R304.5.3, R304.2.2-Perp, R304.3.2-Para, R302.7.2

Compliance	Description	Data	Compliance	Description	Data
N/A	Ramp Length (in)	72.0	Yes	Ramp Slope (%)	5.4
Yes	Ramp Width (in)	48.0	No	Ramp XSlope (%)	2.6
N/A	Flare Type LT	Sloped	N/A	Flare Type RT	N/A
N/A	Flare Slope LT (%)	5.3	N/A	Flare Slope RT (%)	3.7
N/A	Flare Traversable LT?	Yes	N/A	Flare Traversable RT?	No
Yes	Landing Length (in)	118.0	Yes	DWS Provided?	Yes
Yes	Landing Width (in)	48.0	Yes	DWS Contrast?	Yes
No	Landing Slope (%)	2.2	Yes	DWS Length (in)	24.0
Yes	Landing X Slope (%)	0.4	Yes	DWS Full Width?	Yes
N/A	Landing Curb? (Y/N)	No	Yes	DWS Offset (in)	2.0
N/A	Shared Landing?	No			
Yes	Gutter Ponding?	No	Yes	Gutter Slope (%)	1.4
No	Gutter Lip Ht (in)	2.0	Yes	Gutter X Slope (%)	1.5
N/A	Painted X Walk1?	No	N/A	Painted X Walk2?	N/A
	X Walk 1 Direction	To SE		X Walk 2 Direction	N/A
N/A	X Walk 1 Width (in)	N/A	N/A	X Walk 2 Width (in)	N/A
	X Walk 1 Slope (%)	0.1		X Walk 2 Slope (%)	N/A
	X Walk 1 X Slope (%)	2.1		X Walk 2 X Slope (%)	N/A

N/A	Ramp inside XWalk1?	N/A	N/A	Ramp inside XWalk2?	N/A
	Road Slope (%)	N/A	N/A	Clear Space?	Yes
	Road X Slope (%)	N/A	N/A	Clear Space to XWalk (in)	N/A
Yes	Any Obstructions?	No	Yes	Storm Grate/Utility Hazard?	No
	Obstruction Type			Storm Grate/Utility Type	
		N/A			N/A
			Yes	Surface Condition? (G/P)	Good

Possible Solutions:

Remove & Replace Entire Ramp.
