Access Compliance Report

Public Rights-of-Way

(Curb Ramps)

Intersection ID: 9046	Main Street: BRADFORD_DR	Cross Street: HOOVER_ST	Location:	S
ADA ID: 99B71B3C4A81	Ramp Type: Perp	Initial Pass/Fail: Fail	Overall Compliance: No	Severity Score: 25
Codes/Mitigation Info/Possible Solution		Field Measurements/Component Compliance

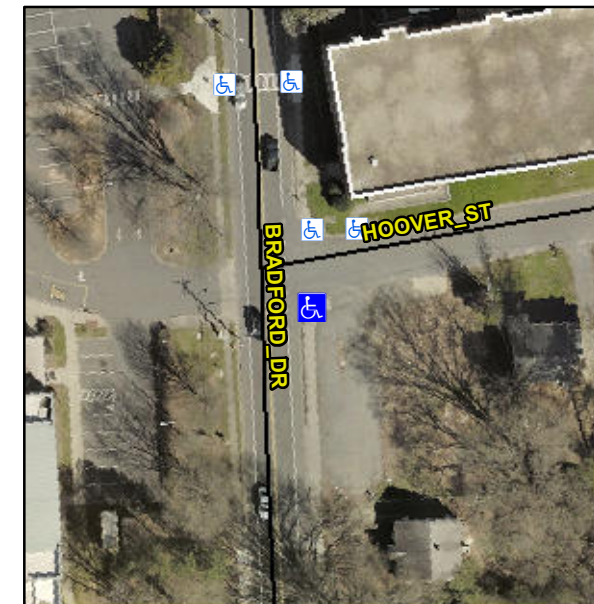
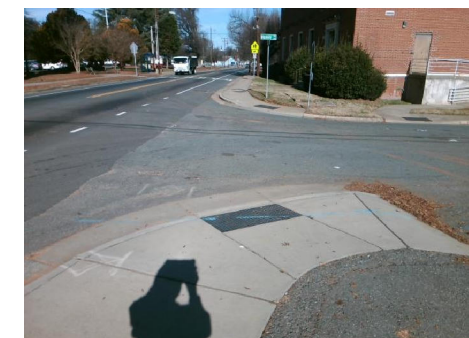
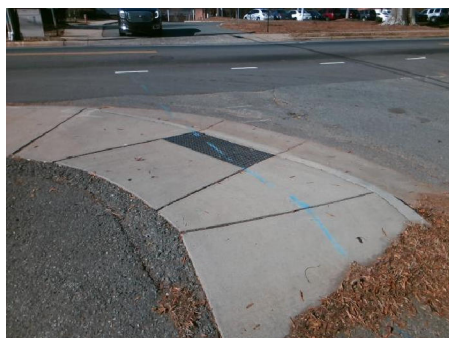
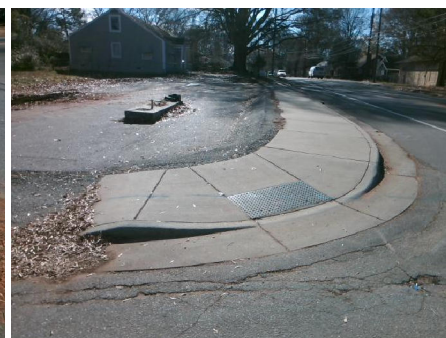
Not Found, R304.2.2, R304.5.3

Compliance	Description	Data	Compliance	Description	Data
N/A	Ramp Length (in)	73.0	No	Ramp Slope (%)	9.9
Yes	Ramp Width (in)	48.2	No	Ramp XSlope (%)	6.0
N/A	Flare Type LT	N/A	N/A	Flare Type RT	N/A
N/A	Flare Slope LT (%)	N/A	N/A	Flare Slope RT (%)	N/A
N/A	Flare Traversable LT?	N/A	N/A	Flare Traversable RT?	N/A
N/A	Landing Length (in)	N/A	N/A	DWS Provided?	N/A
N/A	Landing Width (in)	N/A	N/A	DWS Contrast?	N/A
N/A	Landing Slope (%)	N/A	N/A	DWS Length (in)	N/A
N/A	Landing X Slope (%)	N/A	N/A	DWS Full Width?	N/A
N/A	Landing Curb? (Y/N)	N/A	N/A	DWS Offset (in)	N/A
N/A	Shared Landing?	N/A			
N/A	Gutter Ponding?	N/A	N/A	Gutter Slope (%)	N/A
N/A	Gutter Lip Ht (in)	N/A	N/A	Gutter X Slope (%)	N/A
N/A	Painted X Walk1?	No	N/A	Painted X Walk2?	N/A
	X Walk 1 Direction	To N		X Walk 2 Direction	N/A
N/A	X Walk 1 Width (in)	N/A	N/A	X Walk 2 Width (in)	N/A
	X Walk 1 Slope (%)	2.9		X Walk 2 Slope (%)	N/A
	X Walk 1 X Slope (%)	2.7		X Walk 2 X Slope (%)	N/A

N/A	Ramp inside XWalk1?	N/A	N/A	Ramp inside XWalk2?	N/A
	Road Slope (%)	N/A	N/A	Clear Space?	N/A
	Road X Slope (%)	N/A	N/A	Clear Space to XWalk (in)	N/A
N/A	Any Obstructions?	N/A	N/A	Storm Grate/Utility Hazard?	N/A
	Obstruction Type			Storm Grate/Utility Type	
		N/A			N/A
			Yes	Surface Condition? (G/P)	Good

Possible Solutions:

Remove & Replace Entire Ramp.
