Access Compliance Report

Public Rights-of-Way

(Curb Ramps)

Intersection ID: 11763	Main Street: CARLYLE_DR	Cross Street: THORNTON_RD	Location: NW
ADA ID: 99B9ED416CBE	Ramp Type: Perp	Initial Pass/Fail: Pass	Overall Compliance: No
		Severity Score: 0

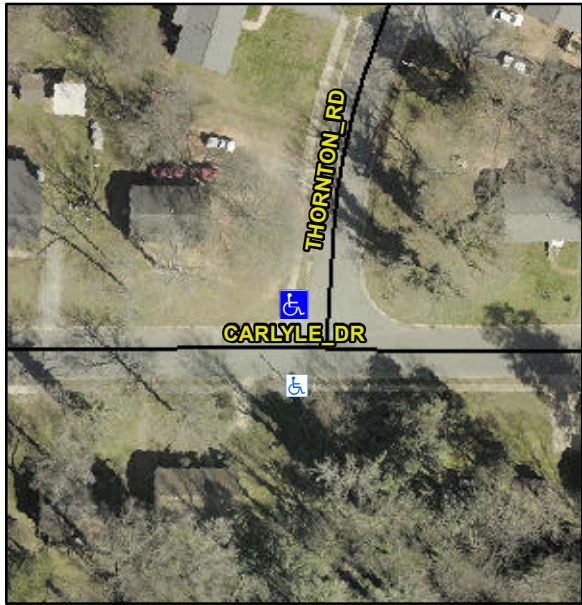
Possible Solutions:		Compliance	Description	Data	Compliance	Description	Data
	Remove & Replace Entire Ramp.		N/A	Ramp Length (in)	49.0	Yes	Ramp Slope (%)	5.9
			Yes	Ramp Width (in)	48.0	Yes	Ramp XSlope (%)	1.2
			N/A	Flare Type LT	Sloped	N/A	Flare Type RT	N/A
			N/A	Flare Slope LT (%)	4.4	Yes	Flare Slope RT (%)	8.8
			N/A	Flare Traversable LT?	No	N/A	Flare Traversable RT?	Yes
			Yes	Landing Length (in)	57.0	Yes	DWS Provided?	Yes
			Yes	Landing Width (in)	48.0	Yes	DWS Contrast?	Yes
			No	Landing Slope (%)	2.5	Yes	DWS Length (in)	24.0
			Yes	Landing X Slope (%)	2.0	Yes	DWS Full Width?	Yes
Surveyor Notes:	N/A		N/A	Landing Curb? (Y/N)	No	Yes	DWS Offset (in)	0.0
			N/A	Shared Landing?	No			
			Yes	Gutter Ponding?	No	Yes	Gutter Slope (%)	1.1
			Yes	Gutter Lip Ht (in)	0.0	Yes	Gutter X Slope (%)	1.1
			N/A	Painted X Walk1?	No	N/A	Painted X Walk2?	N/A

X Walk 1 Direction	To S		X Walk 2 Direction	N/A
			N/A	X Walk 1 Width (in)	N/A	N/A	X Walk 2 Width (in)	N/A
				X Walk 1 Slope (%)	0.4		X Walk 2 Slope (%)	N/A
				X Walk 1 X Slope (%)	0.8		X Walk 2 X Slope (%)	N/A
			N/A	Ramp inside XWalk1?	N/A	N/A	Ramp inside XWalk2?	N/A
PROW/ADA:	Not Found, R304.2.2-Perp, R304.3.2-Para			Road Slope (%)	N/A	N/A	Clear Space?	Yes
				Road X Slope (%)	N/A	N/A	Clear Space to XWalk (in)	N/A
			Yes	Any Obstructions?	No	Yes	Storm Grate/Utility Hazard?	No
				Obstruction Type			Storm Grate/Utility Type	
						N/A		N/A
						Yes	Surface Condition? (G/P)	Good
Street 1 Name		CARLYLE DR						
Stop Condition-Street 2		None						
Street 2 Name		N/A						
Stop Condition-Street 1		N/A						
Total Cost:		\$ 1850.00
