# Access Compliance Report

## Public Rights-of-Way

### (Curb Ramps)

Intersection ID: 19558	Main Street: MANNING_DR	Cross Street: PARK_RD	Location: NE
ADA ID: 99BB2555BC3B	Ramp Type: BlendTrans1	Initial Pass/Fail: Fail	Overall Compliance: No
		Severity Score: 10

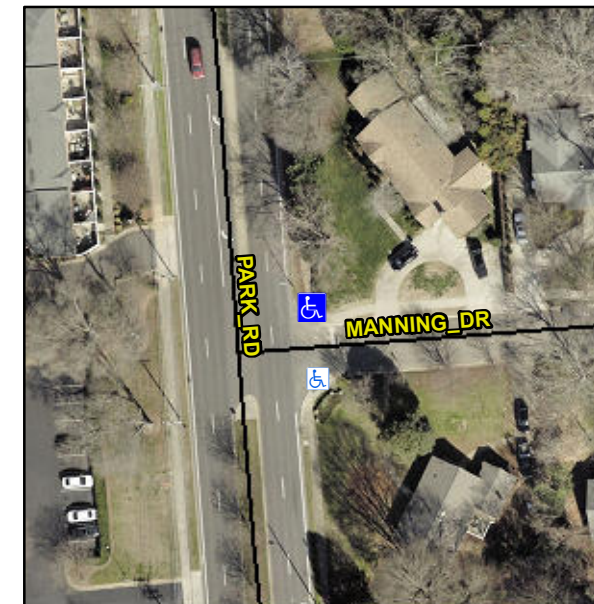
Compliance	Description	Data	Compliance	Description	Data
N/A	Ramp Length (in)	87.0	Yes	BlendTrans Slope (%)	3.5
No	Ramp Width (in)	45.0	No	BlendTrans XSlope (%)	3.2
N/A	Flare Type LT	N/A	N/A	Flare Type RT	N/A
N/A	Flare Slope LT (%)	N/A	N/A	Flare Slope RT (%)	N/A
N/A	Flare Traversable LT?	N/A	N/A	Flare Traversable RT?	N/A
N/A	Landing Length (in)	N/A	N/A	DWS Provided?	N/A
N/A	Landing Width (in)	N/A	N/A	DWS Contrast?	N/A
N/A	Landing Slope (%)	N/A	N/A	DWS Length (in)	N/A
N/A	Landing X Slope (%)	N/A	N/A	DWS Full Width?	N/A
N/A	Landing Curb? (Y/N)	N/A	N/A	DWS Offset (in)	N/A
N/A	Shared Landing?	N/A			
N/A	Gutter Ponding?	N/A	N/A	Gutter Slope (%)	N/A
N/A	Gutter Lip Ht (in)	N/A	N/A	Gutter X Slope (%)	N/A
N/A	Painted X Walk1?	No	N/A	Painted X Walk2?	No
	X Walk 1 Direction	To W		X Walk 2 Direction	To S
	X Walk 1 Width (in)	N/A		X Walk 2 Width (in)	N/A
	X Walk 1 Slope (%)	2.0		X Walk 2 Slope (%)	2.5
	X Walk 1 X Slope (%)	3.5		X Walk 2 X Slope (%)	2.5

N/A	Ramp inside XWalk1?	N/A	N/A	Ramp inside XWalk2?	N/A
	Road Slope (%)	3.5		Clear Space?	N/A
	Road X Slope (%)	1.2	N/A	Clear Space to XWalk (in)	N/A
N/A	Any Obstructions?	N/A	N/A	Storm Grate/Utility Hazard?	N/A
	Obstruction Type			Storm Grate/Utility Type	
		N/A			N/A
			Yes	Surface Condition? (G/P)	Good
			N/A	Curb Slope (%)	5.0

**Remove & Replace Curb Ramp With Two New Directional Ramps or Equivalent.**

**R304.5.1, R304.5.3**
