Intersection ID: 14294		Main Street: EAST_BV		Cross Street: EUCLID_AV		Location:		SE											
ADA ID: 99C4567E5FA9		Ramp Type: Directional1		Initial Pass/Fail: Fail		Overall Compliance: No		Severity Score: 13.75											
Codes/Mitigation Info/Possible Solution				Field Measurements/Component Compliance

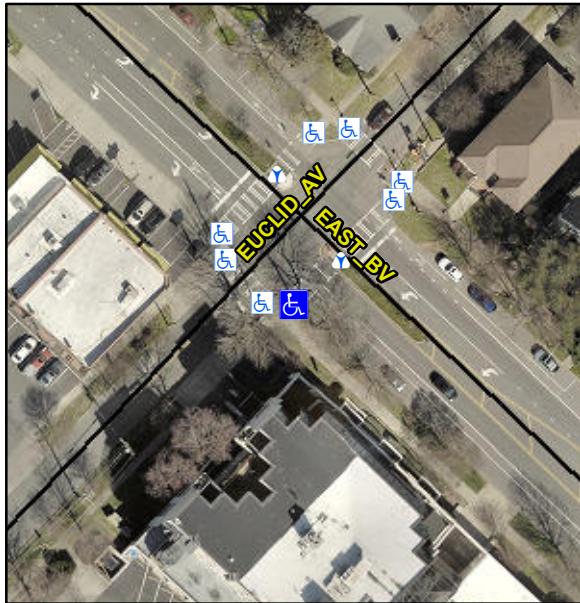
<p>Street 1 Name EAST BV</p> <p>Stop Condition-Street 1 Signal</p> <p>Street 2 Name N/A</p> <p>Stop Condition-Street 2 N/A</p>				Possible Solutions:		Compliance		Description		Data		Compliance		Description		Data			
				Remove & Replace Entire Ramp.		N/A		Ramp Length (in)		71.0		N/A		Grade Break?		N/A		N/A	
						Yes		Ramp Width (in)		71.0		N/A		Grade Break Slope (%)		0.0		0.0	
						No		Ramp Slope (%)		9.0		N/A		Grade Break XSlope (%)		0.0		0.0	
						No		Ramp XSlope (%)		2.1									
						N/A		Flare Type LT		N/A		N/A		Flare Type RT		N/A		N/A	
						N/A		Flare Slope LT (%)		N/A		N/A		Flare Slope RT (%)		0.0		0.0

N/A		Flare Traversable LT?		N/A		N/A		Flare Traversable RT?		N/A		N/A	
						N/A		Landing Length (in)		0.0		N/A		DWS Provided?		N/A		N/A	
						N/A		Landing Width (in)		0.0		N/A		DWS Contrast?		N/A		N/A	
Surveyor Notes:				Compliance		Description		Data		Compliance		Description		Data					
N/A				N/A		Flare Type RT		N/A		N/A		Flare Slope RT (%)		0.0					
				N/A		Flare Traversable RT?		N/A		N/A		DWS Provided?		N/A					
				N/A		DWS Contrast?		N/A		N/A		DWS Length (in)		N/A					
				N/A		DWS Full Width?		N/A		N/A		DWS Offset LT (in)		N/A					
				N/A		DWS Offset RT (in)		N/A		N/A		Gutter Slope (%)		N/A					
				N/A		Gutter X Slope (%)		N/A		N/A		Gutter X Slope (%)		N/A					
				N/A		Painted X Walk1?		Yes				Road Slope (%)		7.8					
				N/A		X Walk 1 Direction		To NE				Road X Slope (%)		1.6					
				N/A		X Walk 1 Width (in)		112.0				Clear Space?		N/A					
				N/A		X Walk 1 Slope (%)		7.8		N/A		Clear Space to XWalk (in)		N/A

N/A		X Walk 1 X Slope (%)		1.6		N/A		Storm Grate/Utility Hazard?		N/A					
				N/A		Ramp inside XWalk1?		Yes				Storm Grate/Utility Type							
				N/A		Any Obstructions?		N/A						N/A					
						Obstruction Type				Yes		Surface Condition? (G/P)		Good					
								N/A		N/A		Curb Slope (%)		5.1					
Total Cost:				\$		1600.00
