Access Compliance Report

Public Rights-of-Way

(Curb Ramps)

Intersection ID: 21442	Main Street: E_ARROWOOD_RD	Cross Street: GRAND_METIS_DR	Location: NW
ADA ID: 99C75C337048	Ramp Type: PerpDiag	Initial Pass/Fail: Fail	Overall Compliance: No
Severity Score: 67.5			
Codes/Mitigation Info/Possible Solution		Field Measurements/Component Compliance

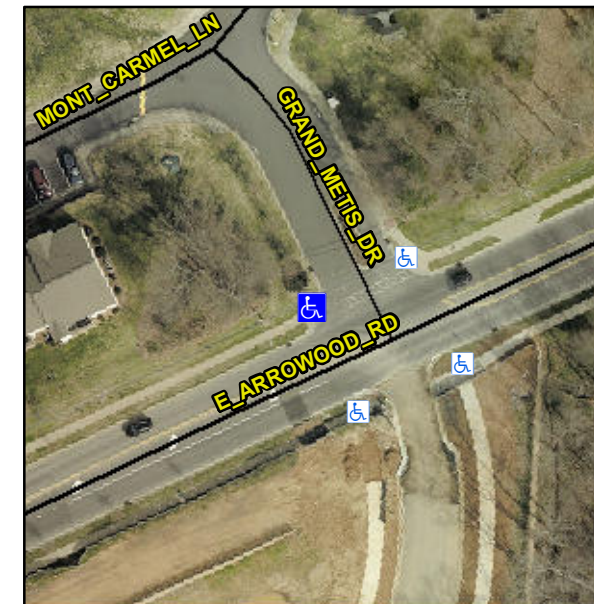
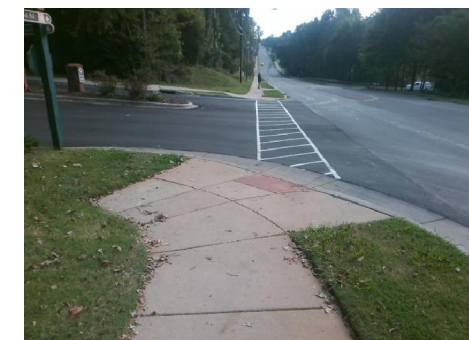
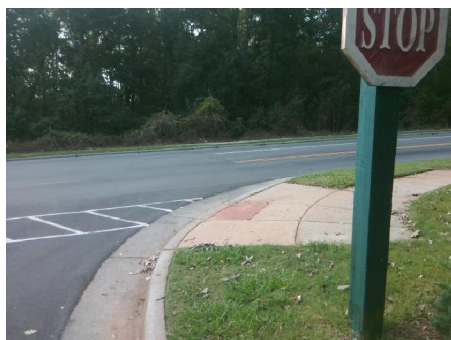
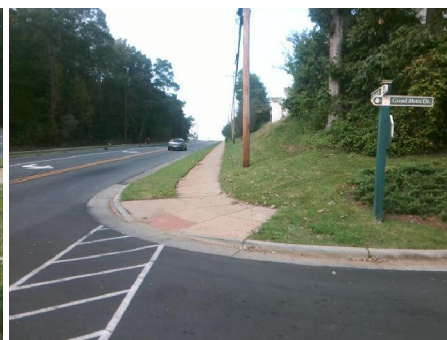
R304.5.1, R304.2.2, R304.5.3

Compliance	Description	Data	Compliance	Description	Data
N/A	Ramp Length (in)	61.0	No	Ramp Slope (%)	12.3
No	Ramp Width (in)	35.0	No	Ramp XSlope (%)	9.1
N/A	Flare Type LT	N/A	N/A	Flare Type RT	N/A
N/A	Flare Slope LT (%)	N/A	N/A	Flare Slope RT (%)	N/A
N/A	Flare Traversable LT?	N/A	N/A	Flare Traversable RT?	N/A
N/A	Landing Length (in)	N/A	N/A	DWS Provided?	N/A
N/A	Landing Width (in)	N/A	N/A	DWS Contrast?	N/A
N/A	Landing Slope (%)	N/A	N/A	DWS Length (in)	N/A
N/A	Landing X Slope (%)	N/A	N/A	DWS Full Width?	N/A
N/A	Landing Curb? (Y/N)	N/A	N/A	DWS Offset (in)	N/A
N/A	Shared Landing?	N/A			
N/A	Gutter Ponding?	N/A	N/A	Gutter Slope (%)	N/A
N/A	Gutter Lip Ht (in)	N/A	N/A	Gutter X Slope (%)	N/A
N/A	Painted X Walk1?	No	N/A	Painted X Walk2?	Yes
	X Walk 1 Direction	To S		X Walk 2 Direction	To NE
N/A	X Walk 1 Width (in)	N/A	N/A	X Walk 2 Width (in)	53.0
	X Walk 1 Slope (%)	2.1		X Walk 2 Slope (%)	7.8
	X Walk 1 X Slope (%)	5.7		X Walk 2 X Slope (%)	0.2

N/A	Ramp inside XWalk1?	N/A	N/A	Ramp inside XWalk2?	Yes
	Road Slope (%)	6.0	N/A	Clear Space?	N/A
	Road X Slope (%)	4.2	N/A	Clear Space to XWalk (in)	N/A
N/A	Any Obstructions?	N/A	N/A	Storm Grate/Utility Hazard?	N/A
	Obstruction Type			Storm Grate/Utility Type	
		N/A			N/A
		Yes		Surface Condition? (G/P)	Good

Remove & Replace Curb Ramp With Two New Directional Ramps or Equivalent.
