Access Compliance Report

Public Rights-of-Way

(Curb Ramps)

Intersection ID: 21411	Main Street: MONROE_RD	Cross Street: SARDIS_RD_NORTH	Location: SW
ADA ID: 99D717936B23	Ramp Type: Para	Initial Pass/Fail: Fail	Overall Compliance: No
			Severity Score: 13.75

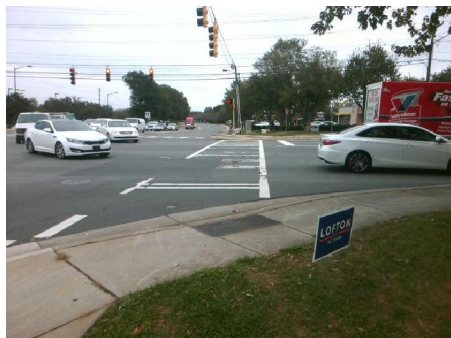
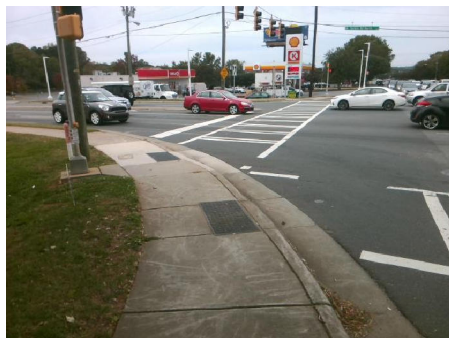
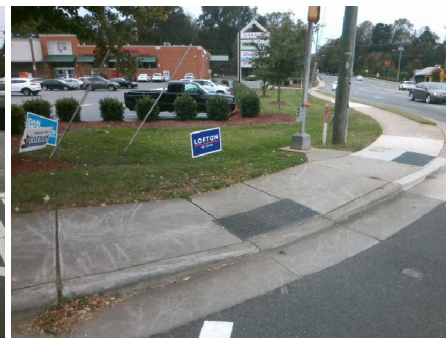
RT RP < 5%

R304.3.2, R304.5.3

Compliance	Description	Data	Compliance	Description	Data
N/A	Ramp Length LT (in)	63.0	N/A	Ramp Length RT (in)	65.0
Yes	Ramp Width LT (in)	59.0	Yes	Ramp Width RT (in)	60.0
No	Ramp Slope LT (%)	9.3	Yes	Ramp Slope RT (%)	3.0
Yes	Ramp XSlope LT (%)	0.8	No	Ramp XSlope RT (%)	3.8
N/A	Landing Length (in)	N/A	N/A	DWS Provided?	N/A
N/A	Landing Width (in)	N/A	N/A	DWS Contrast?	N/A
N/A	Landing Slope (%)	N/A	N/A	DWS Length (in)	N/A
N/A	Landing X Slope (%)	N/A	N/A	DWS Full Width?	N/A
N/A	Landing Curb? (Y/N)	N/A	N/A	DWS Offset (in)	N/A
N/A	Shared Landing?	N/A			
N/A	Gutter Ponding?	N/A	N/A	Gutter Slope (%)	N/A
N/A	Gutter Lip Ht (in)	N/A	N/A	Gutter X Slope (%)	N/A
N/A	Painted X Walk1?	Yes	N/A	Painted X Walk2?	N/A
	X Walk 1 Direction	To NE		X Walk 2 Direction	N/A
N/A	X Walk 1 Width (in)	108.0	N/A	X Walk 2 Width (in)	N/A
	X Walk 1 Slope (%)	0.9		X Walk 2 Slope (%)	N/A
	X Walk 1 X Slope (%)	3.6		X Walk 2 X Slope (%)	N/A
N/A	Ramp inside XWalk1?	Yes	N/A	Ramp inside XWalk2?	N/A

Road Slope (%)	N/A	N/A	Clear Space?	N/A
	Road X Slope (%)	N/A	N/A	Clear Space to XWalk (in)	N/A
N/A	Any Obstructions?	N/A	N/A	Storm Grate/Utility Hazard?	N/A
	Obstruction Type			Storm Grate/Utility Type	
		N/A			N/A
			Yes	Surface Condition? (G/P)	Good
			N/A	Curb Slope (%)	6.3

Remove & Replace Entire Ramp.

Total Cost: \$ 1600.00
