Access Compliance Report Public Rights-of-Way (Curb Ramps)

Intersection ID: 32189 Main Stu	Cross Street: REAVENCREST_PARK_DR					Location:	NE	
ADA ID: 99D8A5050BBB Ramp Type: PerpDiag		Initial Pass/Fail: Fail Overall Compliance: No						30
Codes/Mitigation Info/Possible Solution		Field Measurements/Component Compliance						
5 5 5 5 5 5 5 5 5 5 5 5 5 5 5 5 5 5 5	Possible Solutions:	<u>Co</u>	Compliance Description			Data Compliance Description		
	Remove & Replace Curb Ramp Wit Two New Directional Ramps or Equivalent.	/ith N/	Ά	Ramp Length (in)	93.0	No	Ramp Slope (%)	9.9
		No	D	Ramp Width (in)	35.0	Yes	Ramp XSlope (%)	1.5
		N/.	Α	Flare Type LT	N/A	N/A	Flare Type RT	N/A
		N/.	Ά	Flare Slope LT (%)	N/A	N/A	Flare Slope RT (%)	N/A
		N/.	Ά	Flare Traversable LT?	N/A	N/A	Flare Traversable RT?	N/A
		N/.	Ά	Landing Length (in)	N/A	N/A	DWS Provided?	N/A
	Surveyor Notes:	N/.	Ά	Landing Width (in)	N/A	N/A	DWS Contrast?	N/A
	N/A	N/.	Ά	Landing Slope (%)	N/A	N/A	DWS Length (in)	N/A

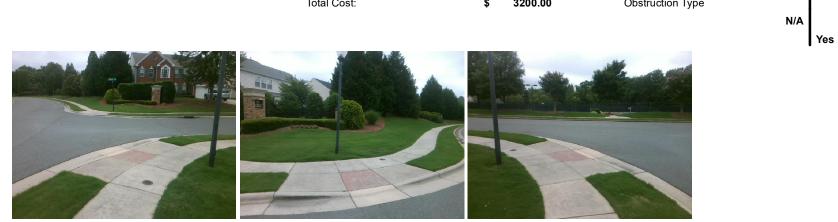
N/.	Α	Landing X Slope (%)	N/A	N/A	DWS Full Width?	N/A
		N/.	Α	Landing Curb? (Y/N)	N/A	N/A	DWS Offset (in)	N/A
		N/.	Α	Shared Landing?	N/A			
	PROW/ADA:	N/.	Ά	Gutter Ponding?	N/A	N/A	Gutter Slope (%)	N/A
	Not Found, R304.5.1, R304.2.2	N/	Ά	Gutter Lip Ht (in)	N/A	N/A	Gutter X Slope (%)	N/A
		N/.	Ά	Painted X Walk1?	No	N/A	Painted X Walk2?	No
				X Walk 1 Direction	To NW		X Walk 2 Direction	To SW
		N/.	Α	X Walk 1 Width (in)	N/A	N/A	X Walk 2 Width (in)	N/A
Street 1 Name LUMLEY DR				X Walk 1 Slope (%)	0.3		X Walk 2 Slope (%)	1.2
Stop Condition-Street 2 StopSign				X Walk 1 X Slope (%)	3.4		X Walk 2 X Slope (%)	0.3
Street 2 Name REAVENCREST PARK DR		N/.	Α	Ramp inside XWalk1?	N/A	N/A	Ramp inside XWalk2?	N/A
Stop Condition-Street 1 None				Road Slope (%)	3.8	N/A	Clear Space?	N/A
				Road X Slope (%)	2.8	N/A	Clear Space to XWalk (in)	N/A
		N/	/ A	Any Obstructions?	N/A	N/A	Storm Grate/Utility Hazard?	N/A
	Total Cost: \$ 32	200.00		Obstruction Type			Storm Grate/Utility Type
