Access Compliance Report

Public Rights-of-Way

(Curb Ramps)

| Intersection ID: 2576 | Main Street: CAMBRIDGE_BAY_DR | Cross Street: WHISTLER'S_CHASE_DR | Location: W |

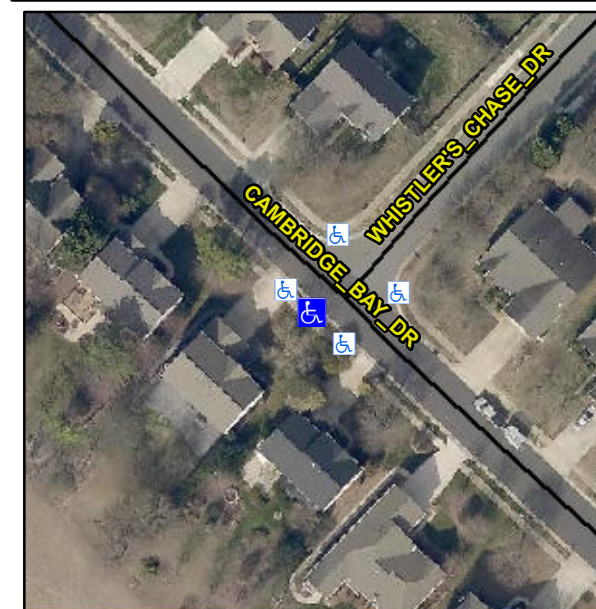
| ADA ID: 99DB321618AD | Ramp Type: Perp | Initial Pass/Fail: Fail | Overall Compliance: No |

Not Found, R304.2.2, R304.5.3

| Compliance | Description | Data | Compliance | Description | Data |
|---|---|---|---|---|---|
| N/A | Ramp Length (in) | 46.5 | No | Ramp Slope (%) | 9.0 |
| Yes | Ramp Width (in) | 48.0 | No | Ramp XSlope (%) | 6.0 |

Possible Solutions:

Remove & Replace Entire Ramp.
