# Access Compliance Report

## Public Rights-of-Way

### (Curb Ramps)

| Intersection ID: 44046 | Main Street: LONGSTONE_LN | Cross Street: ARDREY_KELL_RD | Location: S |

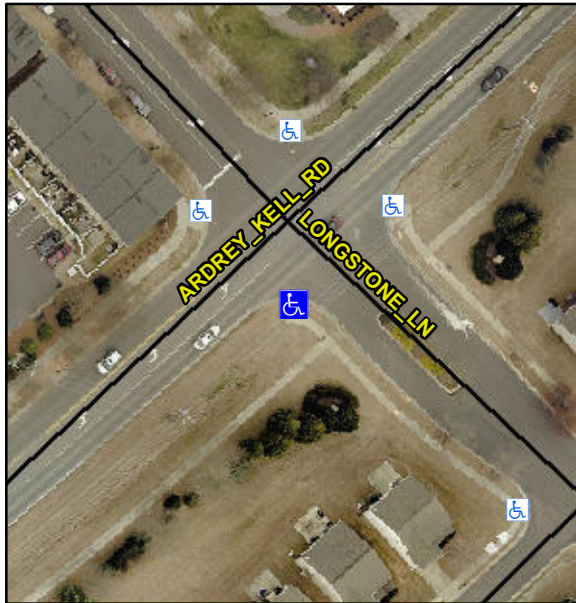
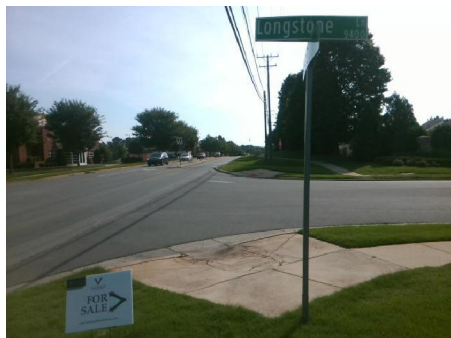
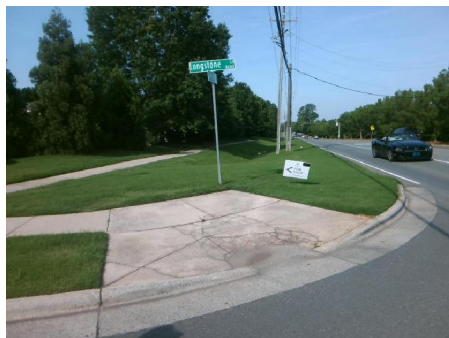
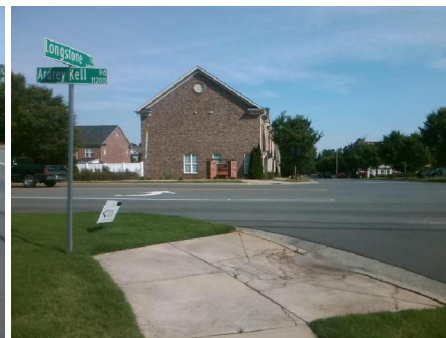
| ADA ID: 99DC44666965 | Ramp Type: PerpDiag | Initial Pass/Fail: Fail | Overall Compliance: No |

| Compliance | Description | Data | Compliance | Description | Data |
|---|---|---|---|---|---|
| N/A | Ramp Length (in) | 48.5 | No | Ramp Slope (%) | 12.2 |
| No | Ramp Width (in) | 35.5 | No | Ramp XSlope (%) | 5.3 |
| | | No | | Surface Condition? (G/P) | Poor |

**Remove & Replace Curb Ramp With Two New Directional Ramps or Equivalent.**

**R304.5.1, R304.2.2, R304.5.3, R302.7**
