Access Compliance Report

Public Rights-of-Way

(Curb Ramps)

Intersection ID: 10030537	Main Street: LITTLE ROCK RD	Cross Street: N/A	Location: NE
ADA ID: 99DCC85E2297	Ramp Type: BlendTrans2	Initial Pass/Fail: Fail	Overall Compliance: No
		Severity Score: 10

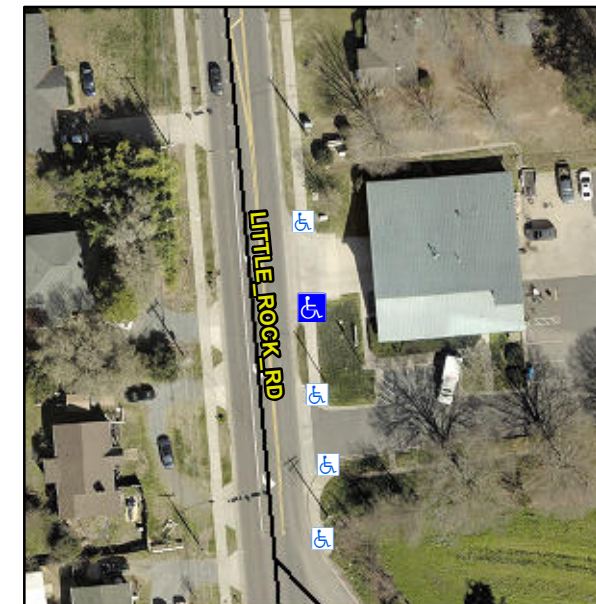
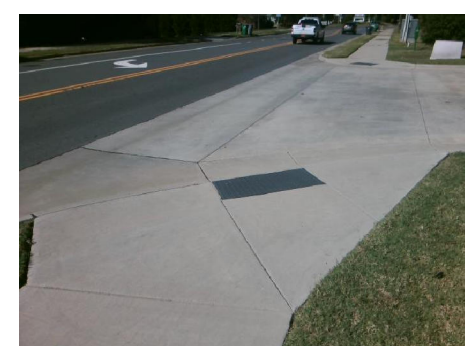
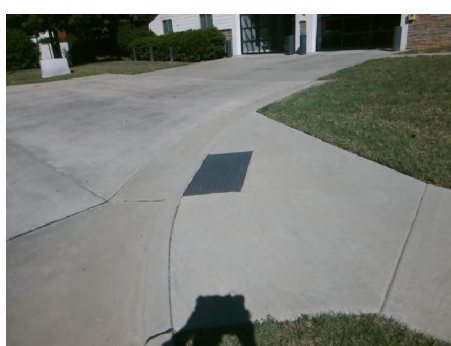
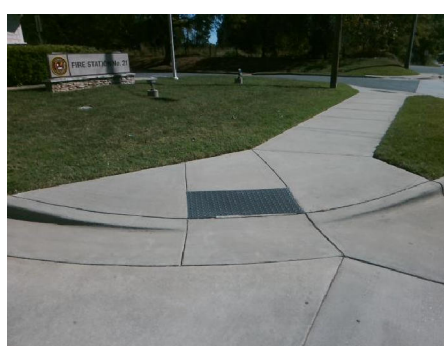
Not Found, R304.5.1, R304.5.3

Compliance	Description	Data	Compliance	Description	Data
N/A	Ramp Length (in)	90.0	Yes	BlendTrans Slope (%)	3.3
No	Ramp Width (in)	47.0	No	BlendTrans XSlope (%)	3.5
N/A	Flare Type LT	N/A	N/A	Flare Type RT	N/A
N/A	Flare Slope LT (%)	N/A	N/A	Flare Slope RT (%)	N/A
N/A	Flare Traversable LT?	N/A	N/A	Flare Traversable RT?	N/A
N/A	Landing Length (in)	N/A	N/A	DWS Provided?	N/A
N/A	Landing Width (in)	N/A	N/A	DWS Contrast?	N/A
N/A	Landing Slope (%)	N/A	N/A	DWS Length (in)	N/A
N/A	Landing X Slope (%)	N/A	N/A	DWS Full Width?	N/A
N/A	Landing Curb? (Y/N)	N/A	N/A	DWS Offset (in)	N/A
N/A	Shared Landing?	N/A			
N/A	Gutter Ponding?	N/A	N/A	Gutter Slope (%)	N/A
N/A	Gutter Lip Ht (in)	N/A	N/A	Gutter X Slope (%)	N/A
N/A	Painted X Walk1?	No	N/A	Painted X Walk2?	No
	X Walk 1 Direction	To N		X Walk 2 Direction	To W
	X Walk 1 Width (in)	N/A		X Walk 2 Width (in)	N/A
	X Walk 1 Slope (%)	0.3		X Walk 2 Slope (%)	3.2
	X Walk 1 X Slope (%)	2.4		X Walk 2 X Slope (%)	0.5

N/A	Ramp inside XWalk1?	N/A	N/A	Ramp inside XWalk2?	N/A
	Road Slope (%)	1.8		Clear Space?	N/A
	Road X Slope (%)	0.7	N/A	Clear Space to XWalk (in)	N/A
N/A	Any Obstructions?	N/A	N/A	Storm Grate/Utility Hazard?	N/A
	Obstruction Type			Storm Grate/Utility Type	
		N/A			N/A
			Yes	Surface Condition? (G/P)	Good
			No	Curb Slope (%)	7.3

Remove & Replace Curb Ramp With Two New Directional Ramps or Equivalent.
