Access Compliance Report

Public Rights-of-Way

(Curb Ramps)

Intersection ID: 14024	Main Street: BASCOM_ST	Cross Street: CHESTERFIELD_AV	Location: W
ADA ID: 99E01208254C	Ramp Type: Perp	Initial Pass/Fail: Fail	Overall Compliance: No
Codes/Mitigation Info/Possible Solution		Field Measurements/Component Compliance	
Severity Score: 48.75

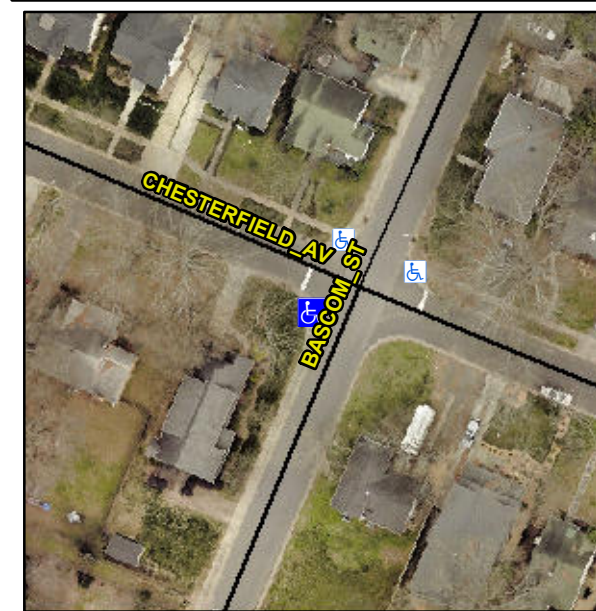
Not Found, R304.5.1, R304.2.2, R304.5.3

Compliance	Description	Data	Compliance	Description	Data
N/A	Ramp Length (in)	61.5	No	Ramp Slope (%)	10.2
No	Ramp Width (in)	27.0	No	Ramp XSlope (%)	3.4
N/A	Flare Type LT	N/A	N/A	Flare Type RT	N/A
N/A	Flare Slope LT (%)	N/A	N/A	Flare Slope RT (%)	N/A
N/A	Flare Traversable LT?	N/A	N/A	Flare Traversable RT?	N/A
N/A	Landing Length (in)	N/A	N/A	DWS Provided?	N/A
N/A	Landing Width (in)	N/A	N/A	DWS Contrast?	N/A
N/A	Landing Slope (%)	N/A	N/A	DWS Length (in)	N/A
N/A	Landing X Slope (%)	N/A	N/A	DWS Full Width?	N/A
N/A	Landing Curb? (Y/N)	N/A	N/A	DWS Offset (in)	N/A
N/A	Shared Landing?	N/A			
N/A	Gutter Ponding?	N/A	N/A	Gutter Slope (%)	N/A
N/A	Gutter Lip Ht (in)	N/A	N/A	Gutter X Slope (%)	N/A
N/A	Painted X Walk1?	No	N/A	Painted X Walk2?	N/A
	X Walk 1 Direction	To NE		X Walk 2 Direction	N/A
N/A	X Walk 1 Width (in)	N/A	N/A	X Walk 2 Width (in)	N/A
	X Walk 1 Slope (%)	2.0		X Walk 2 Slope (%)	N/A
	X Walk 1 X Slope (%)	1.8		X Walk 2 X Slope (%)	N/A

N/A	Ramp inside XWalk1?	N/A	N/A	Ramp inside XWalk2?	N/A
	Road Slope (%)	N/A	N/A	Clear Space?	N/A
	Road X Slope (%)	N/A	N/A	Clear Space to XWalk (in)	N/A
N/A	Any Obstructions?	N/A	N/A	Storm Grate/Utility Hazard?	N/A
	Obstruction Type			Storm Grate/Utility Type	
		N/A			N/A
			Yes	Surface Condition? (G/P)	Good

Possible Solutions:

Remove & Replace Entire Ramp.
