Access Compliance Report

Public Rights-of-Way

(Curb Ramps)

Intersection ID: 7038	Main Street: BROOKWOOD_RD	Cross Street: WOODWIND_ST	Location: SW
ADA ID: 9A0063F03DC1	Ramp Type: BlendTrans1	Initial Pass/Fail: Fail	Overall Compliance: No
Severity Score: 10			
Codes/Mitigation Info/Possible Solution		Field Measurements/Component Compliance

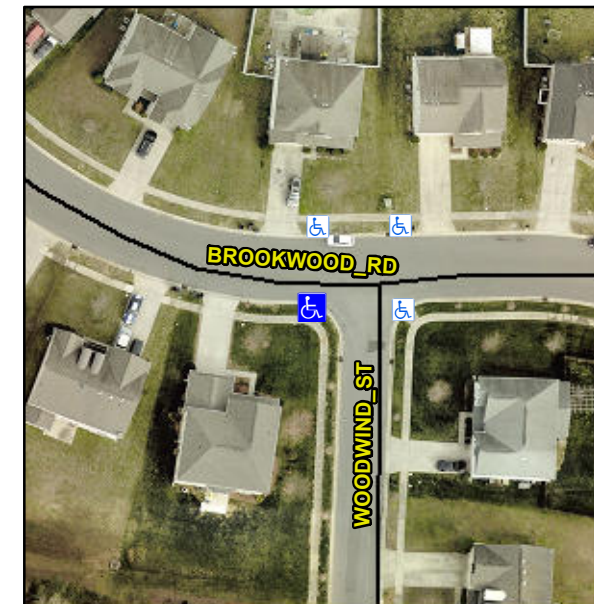
CURB LIP 1.0

Not Found, R304.5.1, R304.5.3

Compliance	Description	Data	Compliance	Description	Data
N/A	Ramp Length (in)	72.0	Yes	BlendTrans Slope (%)	3.2
No	Ramp Width (in)	47.0	No	BlendTrans XSlope (%)	2.5
N/A	Flare Type LT	N/A	N/A	Flare Type RT	N/A
N/A	Flare Slope LT (%)	N/A	N/A	Flare Slope RT (%)	N/A
N/A	Flare Traversable LT?	N/A	N/A	Flare Traversable RT?	N/A
N/A	Landing Length (in)	N/A	N/A	DWS Provided?	N/A
N/A	Landing Width (in)	N/A	N/A	DWS Contrast?	N/A
N/A	Landing Slope (%)	N/A	N/A	DWS Length (in)	N/A
N/A	Landing X Slope (%)	N/A	N/A	DWS Full Width?	N/A
N/A	Landing Curb? (Y/N)	N/A	N/A	DWS Offset (in)	N/A
N/A	Shared Landing?	N/A			
N/A	Gutter Ponding?	N/A	N/A	Gutter Slope (%)	N/A
N/A	Gutter Lip Ht (in)	N/A	N/A	Gutter X Slope (%)	N/A
N/A	Painted X Walk1?	No	N/A	Painted X Walk2?	No
	X Walk 1 Direction	To E		X Walk 2 Direction	To N
	X Walk 1 Width (in)	N/A		X Walk 2 Width (in)	N/A
	X Walk 1 Slope (%)	1.2		X Walk 2 Slope (%)	2.9
	X Walk 1 X Slope (%)	1.9		X Walk 2 X Slope (%)	2.1

N/A	Ramp inside XWalk1?	N/A	N/A	Ramp inside XWalk2?	N/A
	Road Slope (%)	2.7		Clear Space?	N/A
	Road X Slope (%)	0.5	N/A	Clear Space to XWalk (in)	N/A
N/A	Any Obstructions?	N/A	N/A	Storm Grate/Utility Hazard?	N/A
	Obstruction Type			Storm Grate/Utility Type	
		N/A			N/A
			Yes	Surface Condition? (G/P)	Good
			No	Curb Slope (%)	22.4

Remove & Replace Curb Ramp With Two New Directional Ramps or Equivalent.
