Access Compliance Report

Public Rights-of-Way

(Curb Ramps)

Intersection ID: 22936	Main Street: CHESSEL_PL	Cross Street: GORDONVALE_PL	Location: SE
ADA ID: 9A01FFF6EFD3	Ramp Type: PerpDiag	Initial Pass/Fail: Fail	Overall Compliance: No
Severity Score: 25			
Codes/Mitigation Info/Possible Solution		Field Measurements/Component Compliance

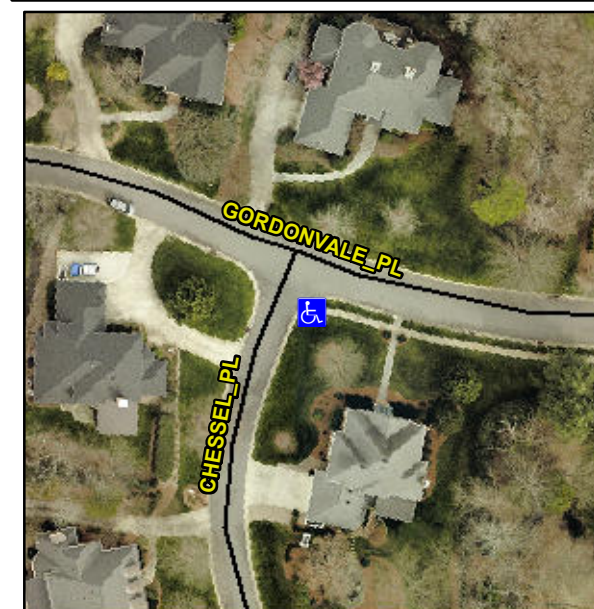
Compliance	Description	Data	Compliance	Description	Data
N/A	Ramp Length (in)	50.0	Yes	Ramp Slope (%)	6.7
Yes	Ramp Width (in)	84.0	No	Ramp XSlope (%)	7.4
N/A	Flare Type LT	N/A	N/A	Flare Type RT	N/A
N/A	Flare Slope LT (%)	N/A	N/A	Flare Slope RT (%)	N/A
N/A	Flare Traversable LT?	N/A	N/A	Flare Traversable RT?	N/A
N/A	Landing Length (in)	N/A	N/A	DWS Provided?	N/A
N/A	Landing Width (in)	N/A	N/A	DWS Contrast?	N/A
N/A	Landing Slope (%)	N/A	N/A	DWS Length (in)	N/A
N/A	Landing X Slope (%)	N/A	N/A	DWS Full Width?	N/A
N/A	Landing Curb? (Y/N)	N/A	N/A	DWS Offset (in)	N/A
N/A	Shared Landing?	N/A			
N/A	Gutter Ponding?	N/A	N/A	Gutter Slope (%)	N/A
N/A	Gutter Lip Ht (in)	N/A	N/A	Gutter X Slope (%)	N/A
N/A	Painted X Walk1?	No	N/A	Painted X Walk2?	No
	X Walk 1 Direction	To N		X Walk 2 Direction	To NW
N/A	X Walk 1 Width (in)	N/A	N/A	X Walk 2 Width (in)	N/A
	X Walk 1 Slope (%)	4.7		X Walk 2 Slope (%)	4.1
	X Walk 1 X Slope (%)	5.2		X Walk 2 X Slope (%)	3.2

N/A	Ramp inside XWalk1?	N/A	N/A	Ramp inside XWalk2?	N/A
	Road Slope (%)	7.5	N/A	Clear Space?	N/A
	Road X Slope (%)	5.2	N/A	Clear Space to XWalk (in)	N/A
N/A	Any Obstructions?	N/A	N/A	Storm Grate/Utility Hazard?	N/A
	Obstruction Type			Storm Grate/Utility Type	
		N/A			N/A
		Yes		Surface Condition? (G/P)	Good

Remove & Replace Curb Ramp With Two New Directional Ramps or Equivalent.
