Access Compliance Report

Public Rights-of-Way

(Curb Ramps)

Intersection ID: 14392	Main Street: HARDING_PL	Cross Street: KENILWORTH_AV	Location: W
ADA ID: 9A0AC3CA217E	Ramp Type: PerpDiag	Initial Pass/Fail: Fail	Overall Compliance: No
		Severity Score: 25

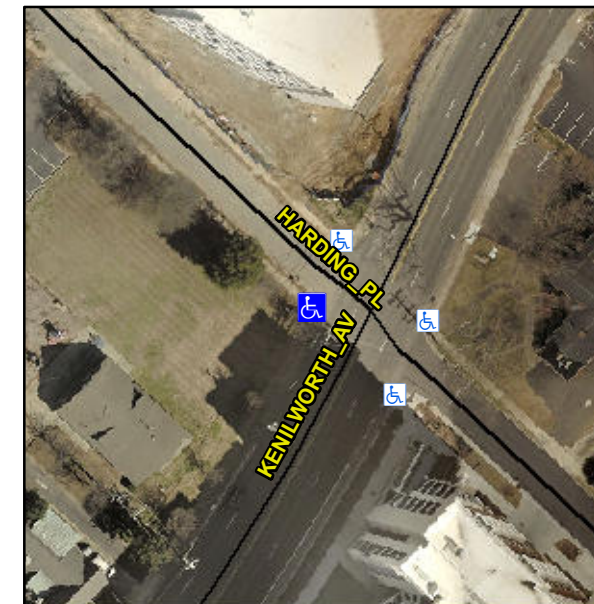
Compliance	Description	Data	Compliance	Description	Data
N/A	Ramp Length (in)	46.0	No	Ramp Slope (%)	14.8
Yes	Ramp Width (in)	48.0	Yes	Ramp XSlope (%)	0.4
N/A	Flare Type LT	N/A	N/A	Flare Type RT	N/A
N/A	Flare Slope LT (%)	N/A	N/A	Flare Slope RT (%)	N/A
N/A	Flare Traversable LT?	N/A	N/A	Flare Traversable RT?	N/A
N/A	Landing Length (in)	N/A	N/A	DWS Provided?	N/A
N/A	Landing Width (in)	N/A	N/A	DWS Contrast?	N/A
N/A	Landing Slope (%)	N/A	N/A	DWS Length (in)	N/A
N/A	Landing X Slope (%)	N/A	N/A	DWS Full Width?	N/A
N/A	Landing Curb? (Y/N)	N/A	N/A	DWS Offset (in)	N/A
N/A	Shared Landing?	N/A			
N/A	Gutter Ponding?	N/A	N/A	Gutter Slope (%)	N/A
N/A	Gutter Lip Ht (in)	N/A	N/A	Gutter X Slope (%)	N/A
N/A	Painted X Walk1?	No	N/A	Painted X Walk2?	No
	X Walk 1 Direction	To SE		X Walk 2 Direction	To NE
N/A	X Walk 1 Width (in)	N/A	N/A	X Walk 2 Width (in)	N/A
	X Walk 1 Slope (%)	1.1		X Walk 2 Slope (%)	2.1
	X Walk 1 X Slope (%)	1.0		X Walk 2 X Slope (%)	1.0

N/A	Ramp inside XWalk1?	N/A	N/A	Ramp inside XWalk2?	N/A
	Road Slope (%)	1.3	N/A	Clear Space?	N/A
	Road X Slope (%)	2.9	N/A	Clear Space to XWalk (in)	N/A
N/A	Any Obstructions?	N/A	N/A	Storm Grate/Utility Hazard?	N/A
	Obstruction Type			Storm Grate/Utility Type	
		N/A			N/A
			Yes	Surface Condition? (G/P)	Good

Remove & Replace Curb Ramp With Two New Directional Ramps or Equivalent.
