# Access Compliance Report

## Public Rights-of-Way

### (Curb Ramps)

Intersection ID: 17739	Main Street: E_WOODLAWN_RD	Cross Street: SOUTH_BV	Location: NE
ADA ID: 9A0D3AFADEDD	Ramp Type: Perp	Initial Pass/Fail: Fail	Overall Compliance: No
Severity Score: 12.5			
Codes/Mitigation Info/Possible Solution		Field Measurements/Component Compliance

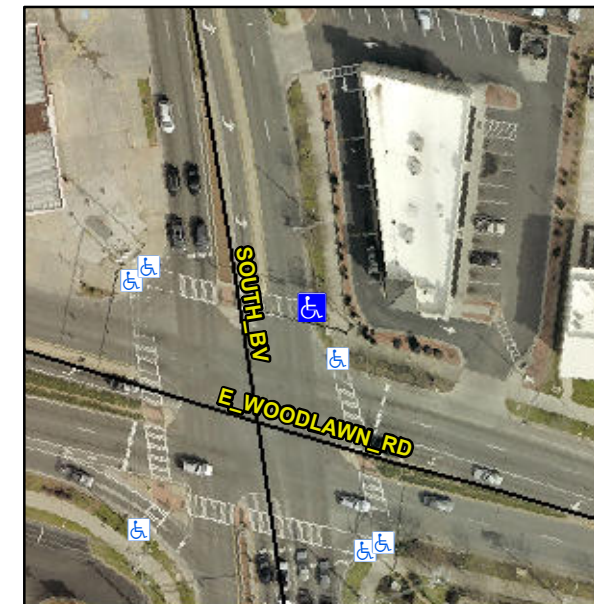
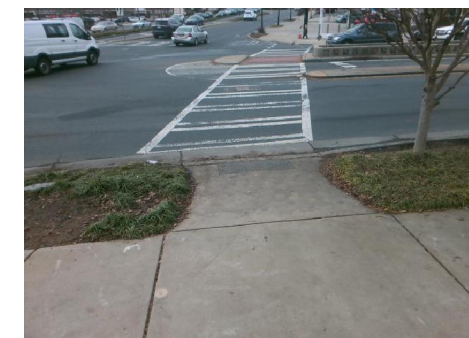
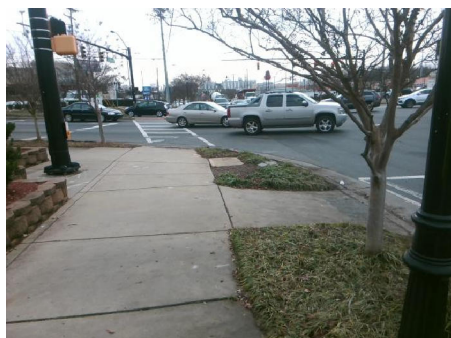
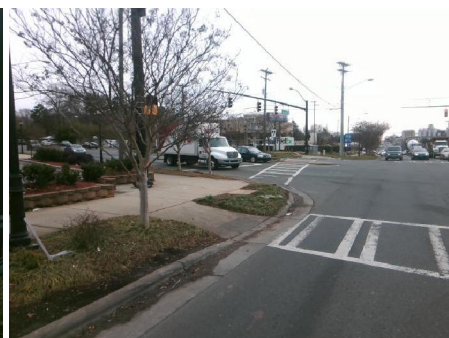
**Not Found, R304.2.2**

Compliance	Description	Data	Compliance	Description	Data
N/A	Ramp Length (in)	96.0	No	Ramp Slope (%)	11.6
Yes	Ramp Width (in)	48.0	Yes	Ramp XSlope (%)	1.5
N/A	Flare Type LT	N/A	N/A	Flare Type RT	N/A
N/A	Flare Slope LT (%)	N/A	N/A	Flare Slope RT (%)	N/A
N/A	Flare Traversable LT?	N/A	N/A	Flare Traversable RT?	N/A
N/A	Landing Length (in)	N/A	N/A	DWS Provided?	N/A
N/A	Landing Width (in)	N/A	N/A	DWS Contrast?	N/A
N/A	Landing Slope (%)	N/A	N/A	DWS Length (in)	N/A
N/A	Landing X Slope (%)	N/A	N/A	DWS Full Width?	N/A
N/A	Landing Curb? (Y/N)	N/A	N/A	DWS Offset (in)	N/A
N/A	Shared Landing?	N/A			
N/A	Gutter Ponding?	N/A	N/A	Gutter Slope (%)	N/A
N/A	Gutter Lip Ht (in)	N/A	N/A	Gutter X Slope (%)	N/A
N/A	Painted X Walk1?	Yes	N/A	Painted X Walk2?	N/A
	X Walk 1 Direction	To NW		X Walk 2 Direction	N/A
N/A	X Walk 1 Width (in)	120.0	N/A	X Walk 2 Width (in)	N/A
	X Walk 1 Slope (%)	1.9		X Walk 2 Slope (%)	N/A
	X Walk 1 X Slope (%)	1.2		X Walk 2 X Slope (%)	N/A

N/A	Ramp inside XWalk1?	Yes	N/A	Ramp inside XWalk2?	N/A
	Road Slope (%)	N/A	N/A	Clear Space?	N/A
	Road X Slope (%)	N/A	N/A	Clear Space to XWalk (in)	N/A
N/A	Any Obstructions?	N/A	N/A	Storm Grate/Utility Hazard?	N/A
	Obstruction Type			Storm Grate/Utility Type	
		N/A			N/A
		Yes		Surface Condition? (G/P)	Good

**Remove & Replace Entire Ramp.**

Total Cost: \$ 1850.00
