## **Access Compliance Report Public Rights-of-Way** (Curb Ramps)

Intersection ID: 11867 Main Street: E\_17TH\_ST Cross Street: SEIGLE\_AV Location: SW **Overall Compliance: No** Severity Score: 21.25 ADA ID: 9A0FFF321553 Ramp Type: Perp Initial Pass/Fail: Fail

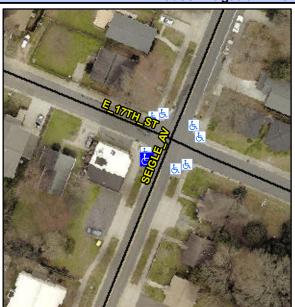
Field Measurements/Component Compliance						
Comp	liance Description	Data	Comp	liance	Description	Data
N/A	Ramp Length (in)	46.0	Yes	Ramp	Slope (%)	5.0
No	Ramp Width (in)	47.5	No	Ramp	XSlope (%)	6.9
N/A	Flare Type LT	N/A	N/A	Flare Type RT		N/A
N/A	Flare Slope LT (%)	N/A	N/A	Flare Slope RT (%)		N/A
N/A	Flare Traversable LT?	N/A	N/A	Flare Traversable RT?		N/A
N/A	Landing Length (in)	N/A	N/A	DWS Provided?		N/A
N/A	Landing Width (in)	N/A	N/A	DWS	Contrast?	N/A
N/A	Landing Slope (%)	N/A	N/A	DWS	Length (in)	N/A
N/A	Landing X Slope (%)	N/A	N/A	DWS	Full Width?	N/A
N/A	Landing Curb? (Y/N)	N/A	N/A	DWS	Offset (in)	N/A
N/A	Shared Landing?	N/A				
N/A	Gutter Ponding?	N/A	N/A	Gutter Slope (%)		N/A
N/A	Gutter Lip Ht (in)	0.5	N/A	Gutter X Slope (%)		N/A
N/A	Painted X Walk1?	No	N/A	Painted X Walk2?		N/A
	X Walk 1 Direction	To SE		X Wa	lk 2 Direction	N/A
N/A	X Walk 1 Width (in)	N/A	N/A	X Wa	lk 2 Width (in)	N/A
	X Walk 1 Slope (%)	1.0		X Wa	lk 2 Slope (%)	N/A

X Walk 1 X Slope (%)	6.8		X Wa	lk 2 X Slope (%)	N/A
N/A	Ramp inside XWalk1?	N/A	N/A	Ramp	inside XWalk2?	N/A
	Road Slope (%)	N/A	N/A	Clear	Space?	N/A
	Road X Slope (%)	N/A	N/A	Clear	Space to XWalk (in)	N/A
N/A	Any Obstructions?	N/A	N/A	Storm	Grate/Utility Hazard?	N/A
	Obstruction Type			Storm	Grate/Utility Type	
		N/A				N/A
			Yes	Surfa	ce Condition? (G/P)	Good

100	Possible Solutions:	<u>c</u>
	Remove & Replace Entire Ramp.	N
		N
		N
		N
		N
		N
	Surveyor Notes:	N
	N/A	N
20		N
1000		N
20.0		N
	PROW/ADA:	N
S S	Not Found, R304.5.1, R304.5.3	N
STATE OF THE PARTY		N
Š		
8		N
		_
		N
